Kelsall Tributary Restoration

Post-construction Monitoring Report - September 27, 2022

Project Goal: Improve fish passage on an unnamed tributary of the Kelsall River (AWC listed stream 115-32-10250-2143-3001) by raising the water surface to resolve a perched culvert.

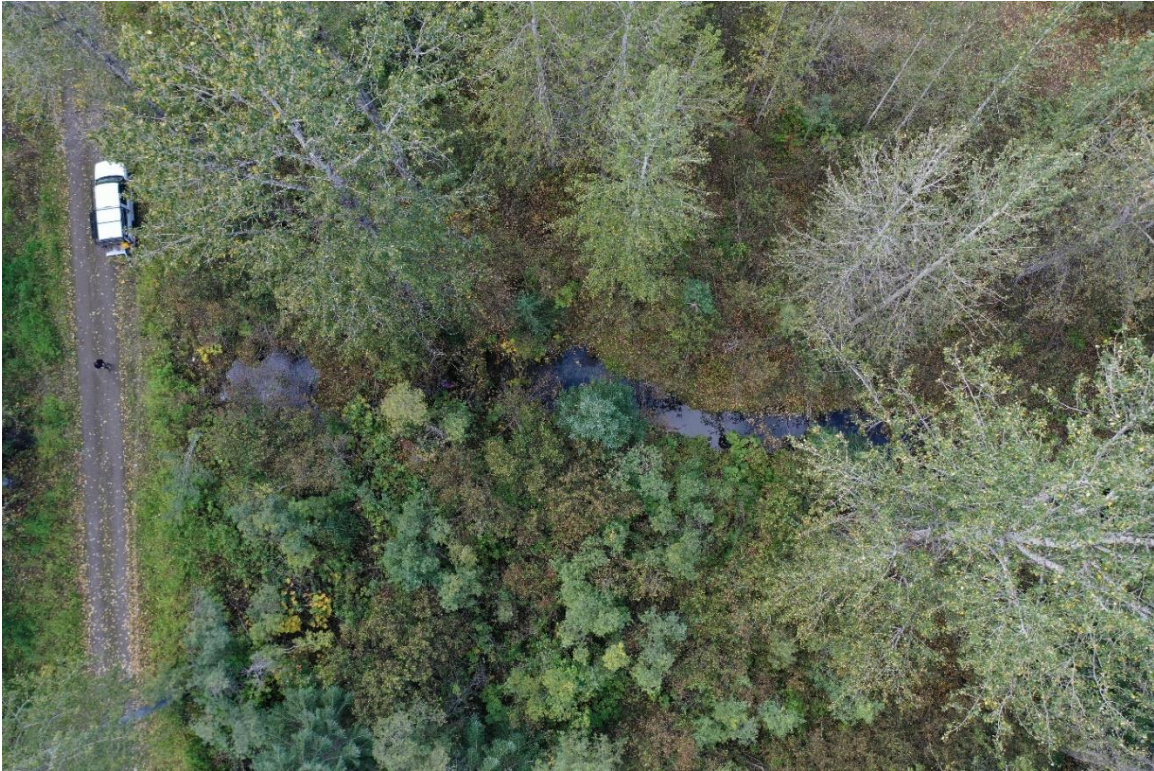
Project site from road to downstream reach.

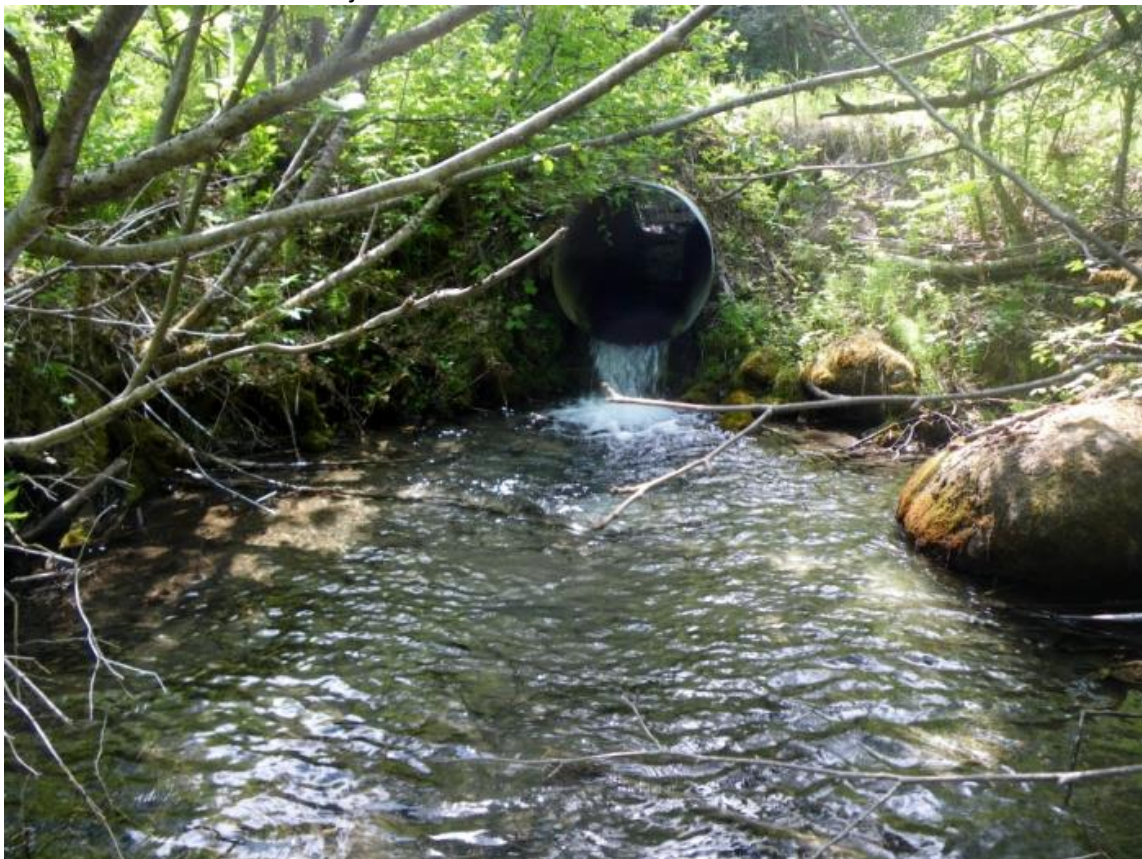
Pre-construction perch causing a barrier to fish passage.

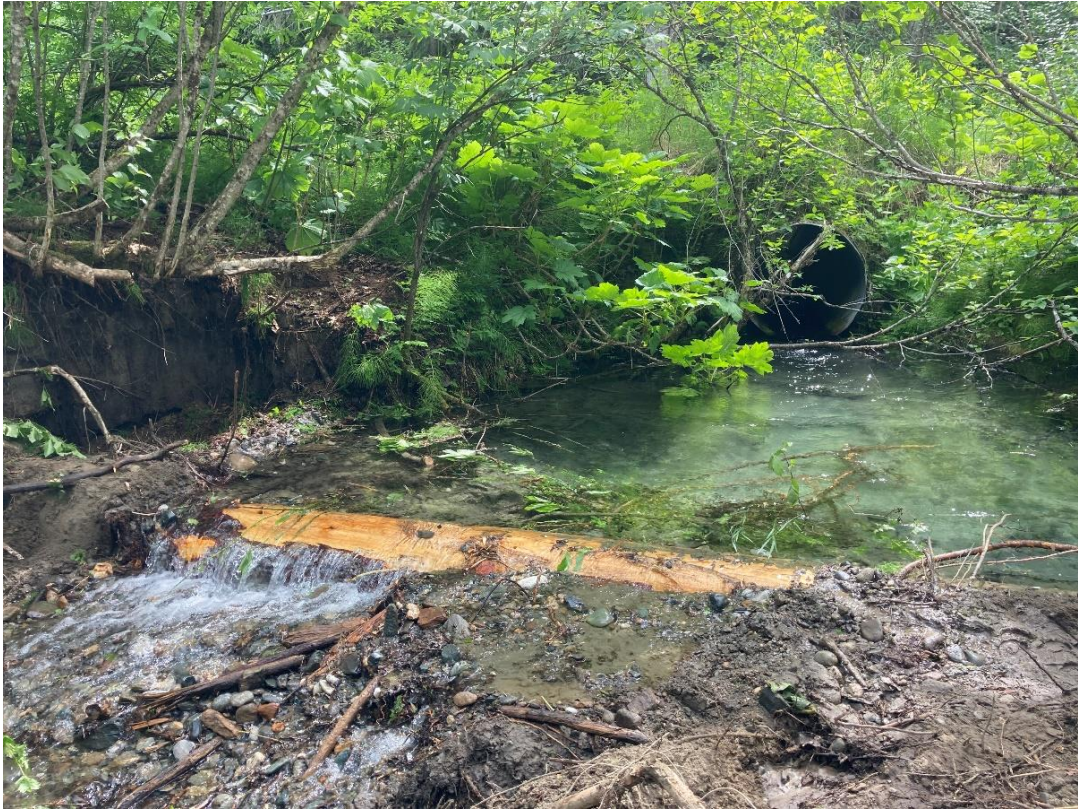
Resulting pool after first log is placed, embedded, and notched. Perch is resolved immediately!

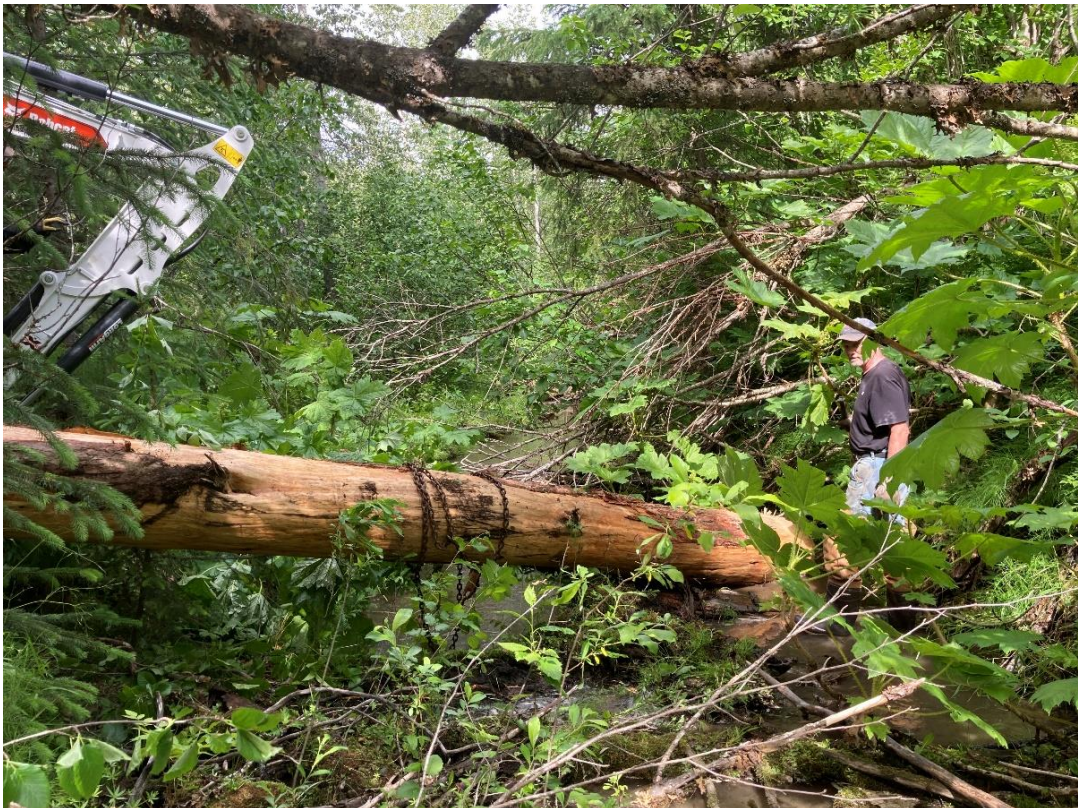
Placing second log.

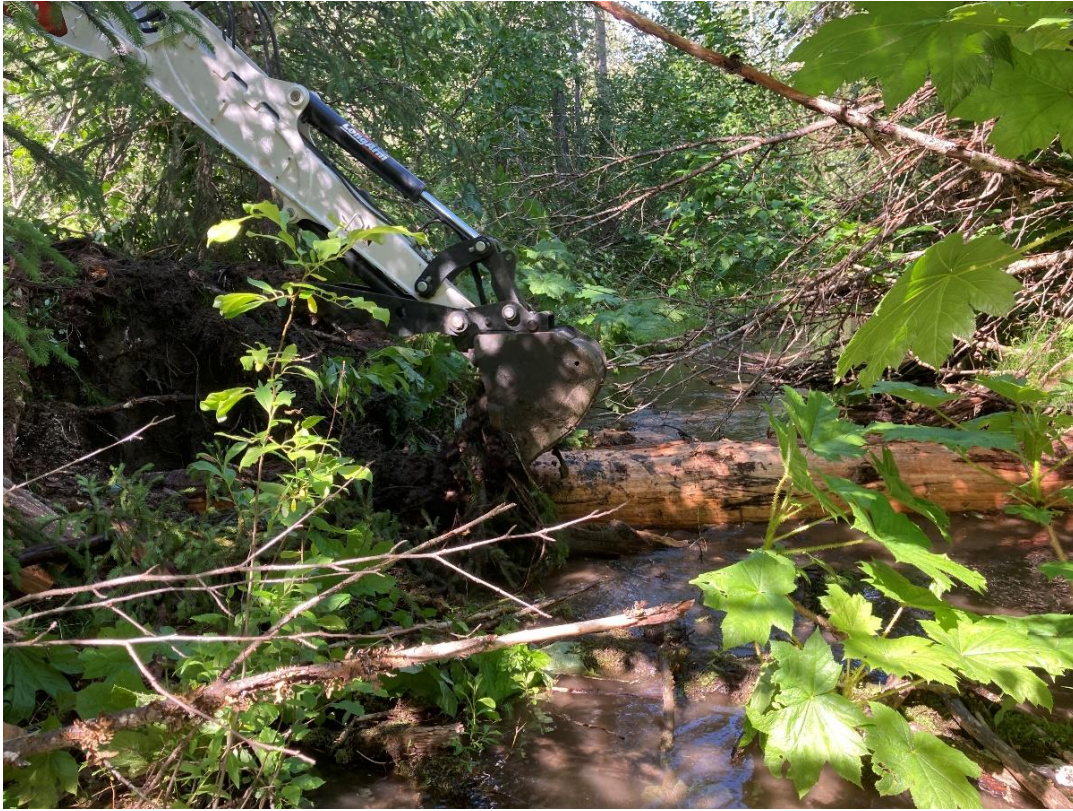
Embedding second log.

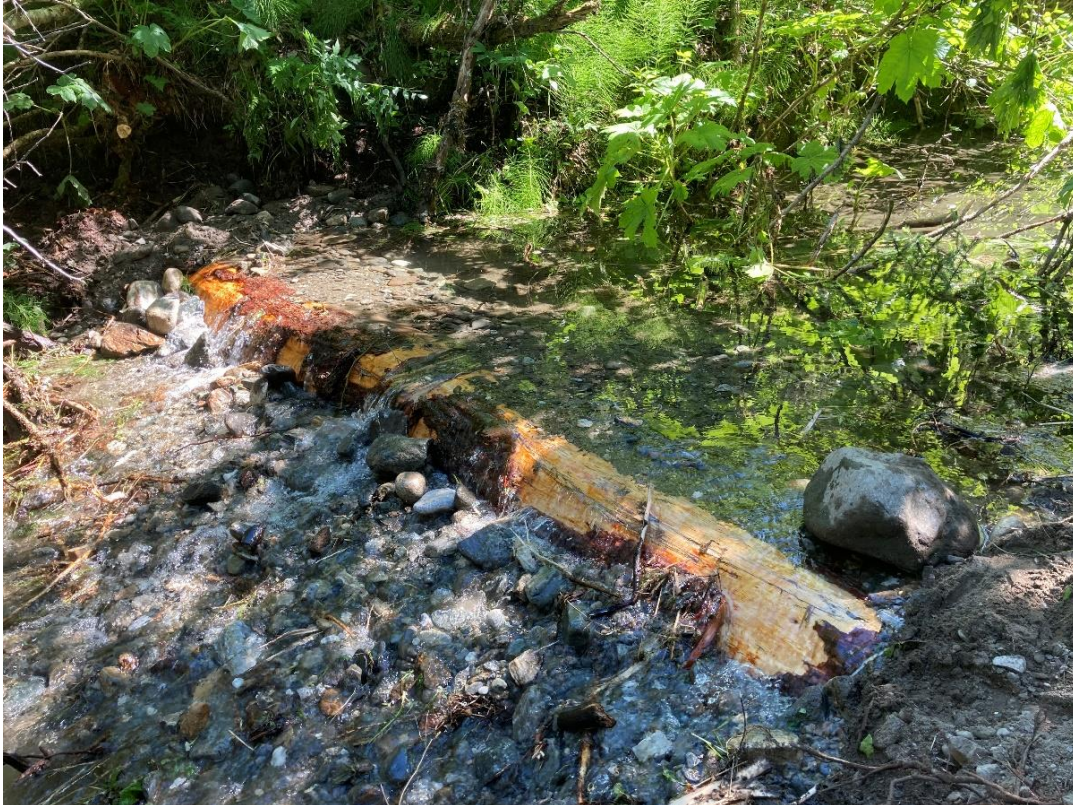
Resulting pool after second log is placed, embedded, and notched.

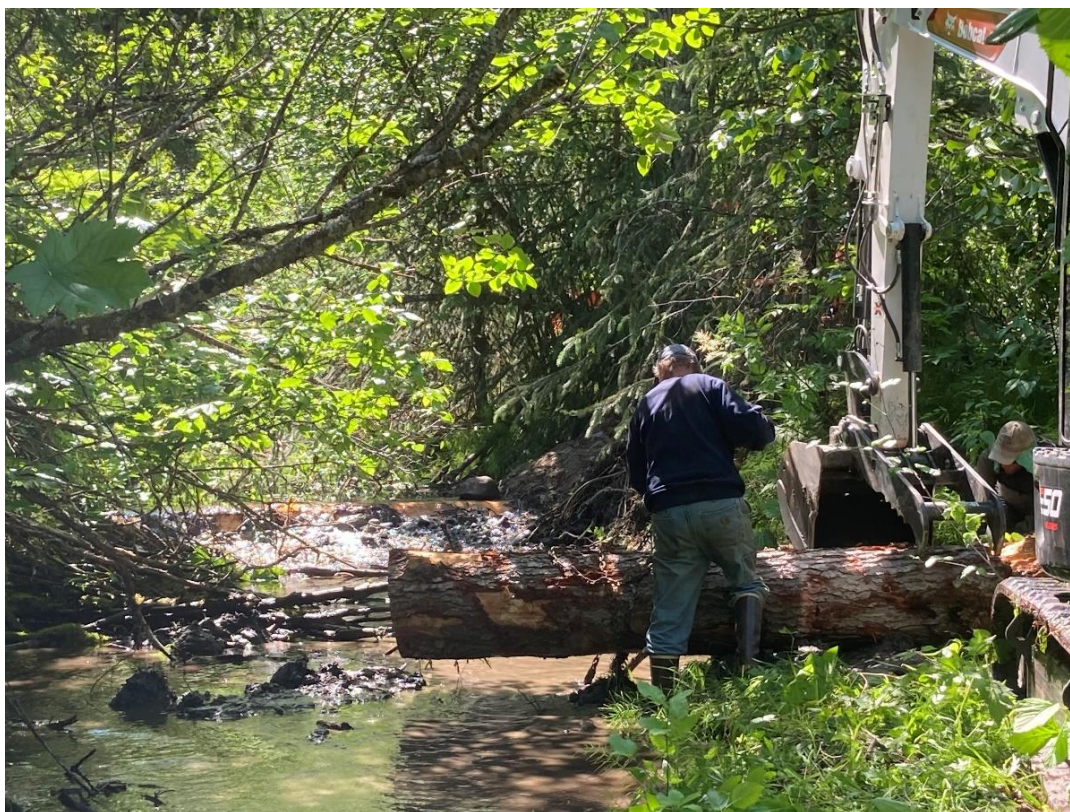
Placing third log

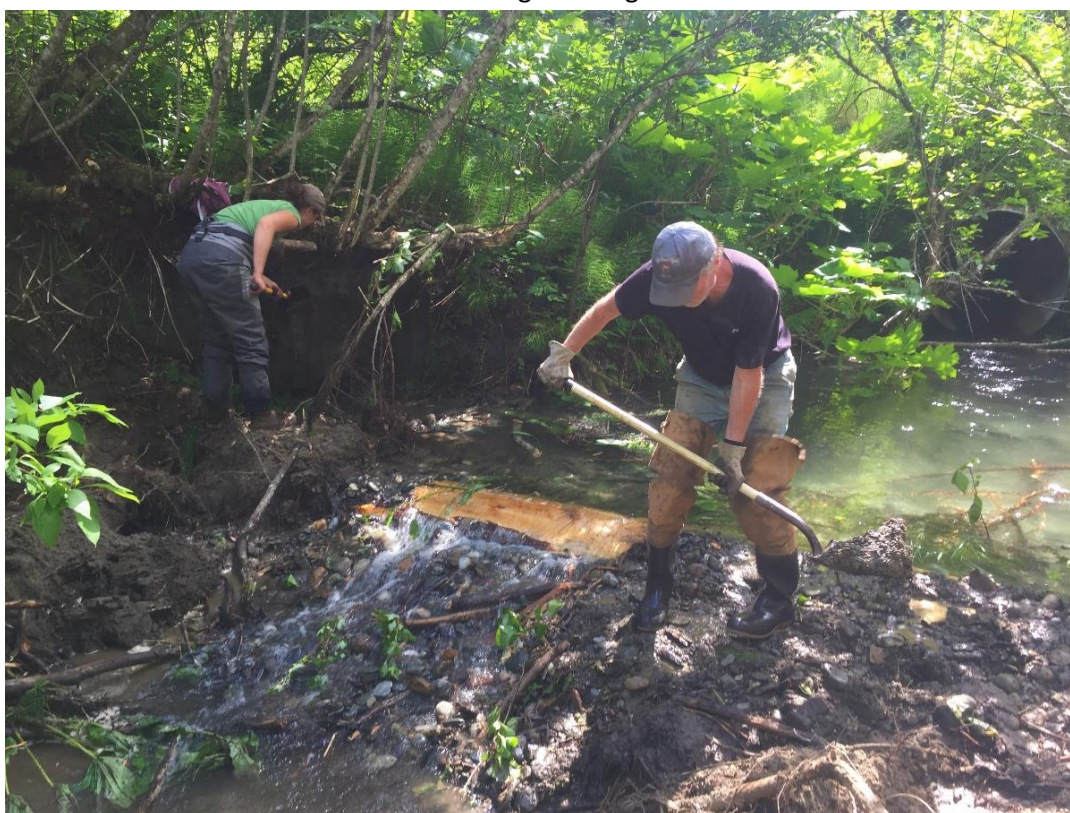
Shoring up weirs with hand tools.

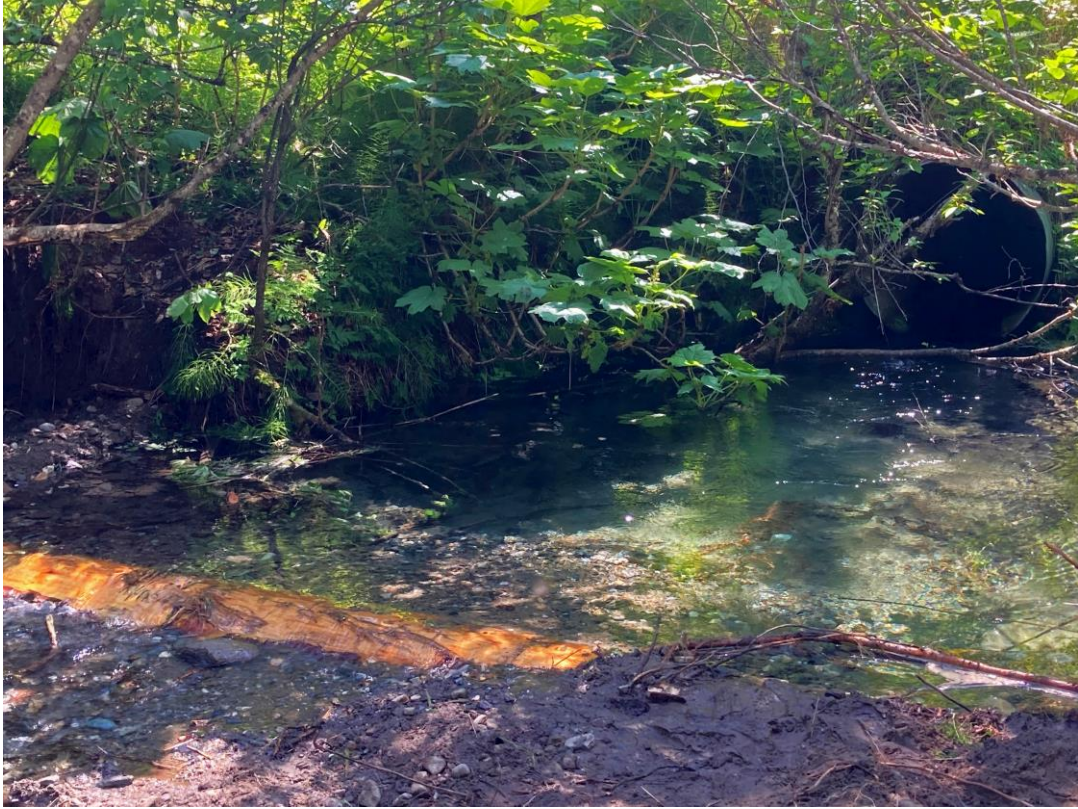
Resulting stream surface elevation after all three weirs are placed. Perch is resolved and step pools allow fish passage. Habitat is enhanced by removing silt from stream bed and creating pools.

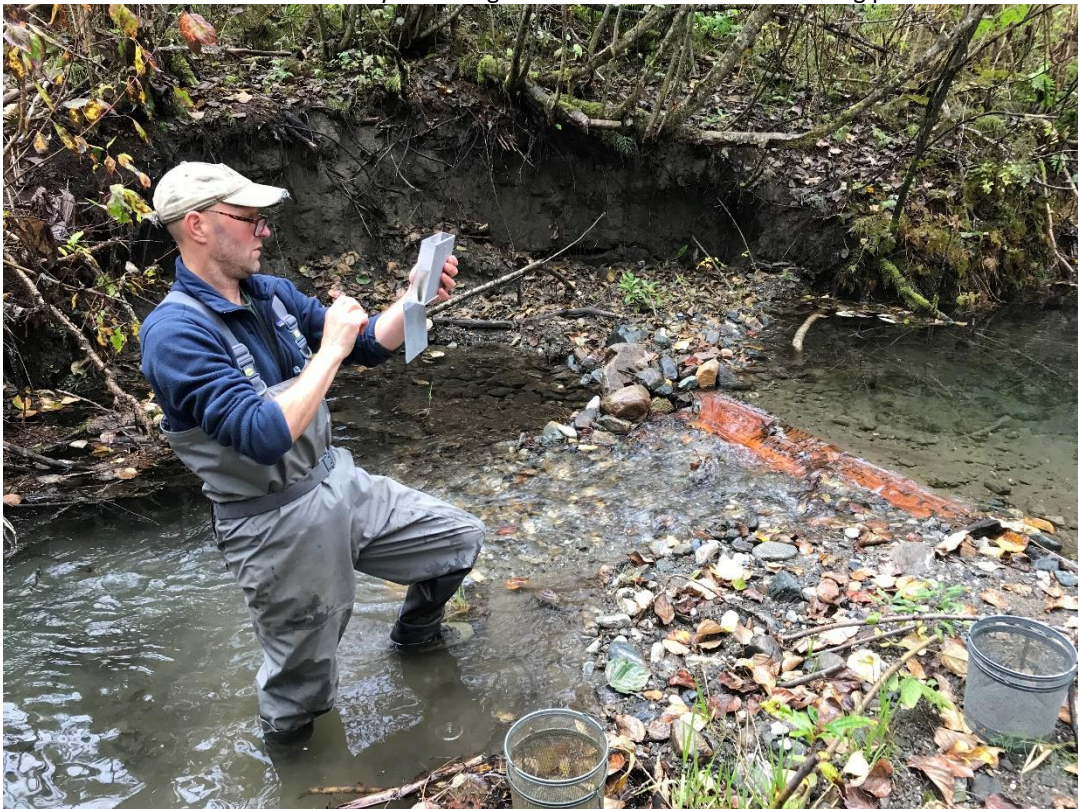
Minnow trapping on 9/21/22 indicates adequate fish passage through project site. Streambank revegetation is occurring.

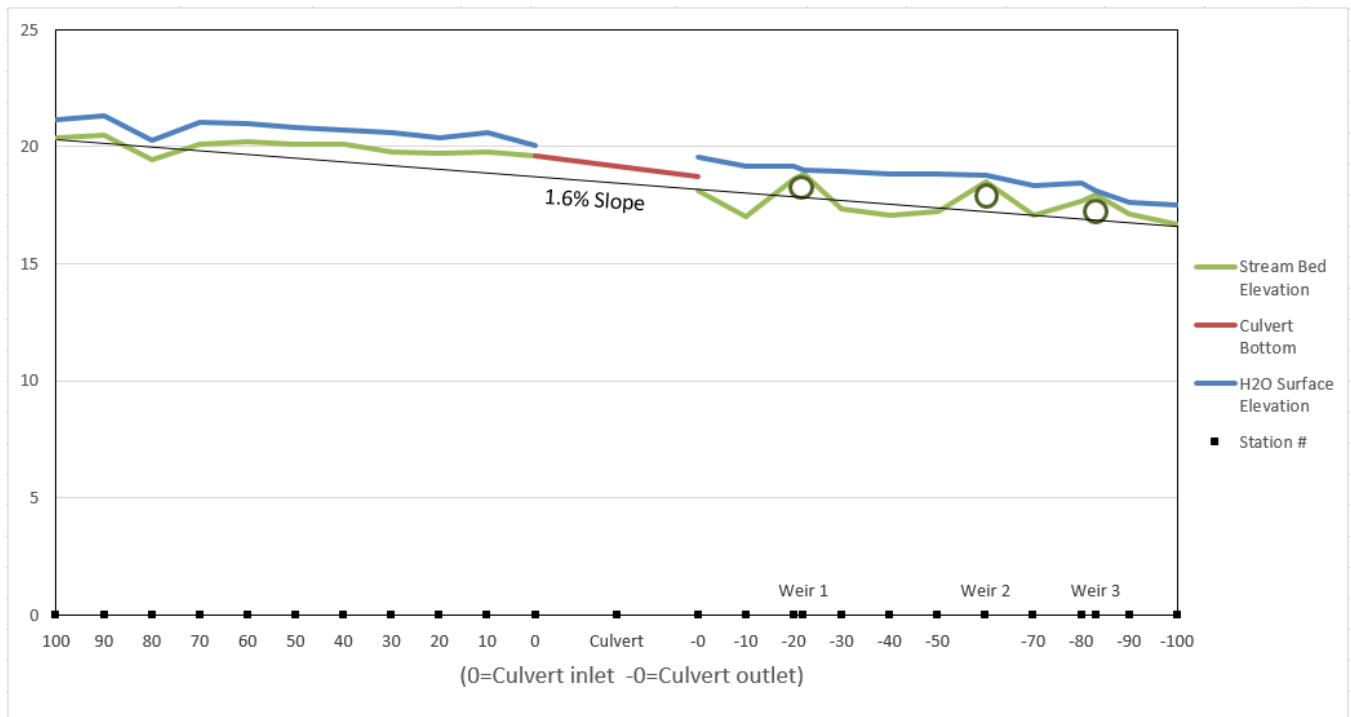
As-Built Longitudinal Streambed Profile Survey: Streambed elevation was measured at estimated center of thalweg on 9/21/2022, three months after step pools were built. Measurements were also taken from the notch on each weir log.

As demonstrated in the post construction survey, new pools were created downstream of the culvert and the water surface elevation was sufficiently raised to eliminate the perch.
