Takshanuk Watershed Council Progress Report August 2020

Mink Creek Culvert Removal and Stream Rehabilitation

Project Goal: Improve fish passage on Mink Creek (AWC listed stream 115-34-10210) by removing a failing culvert and associated road bed material.

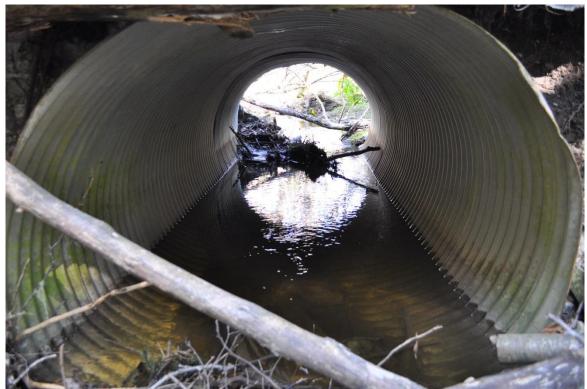
Woody debris collecting at culvert mouths, potentially impeding fish passage. 5/13/2020

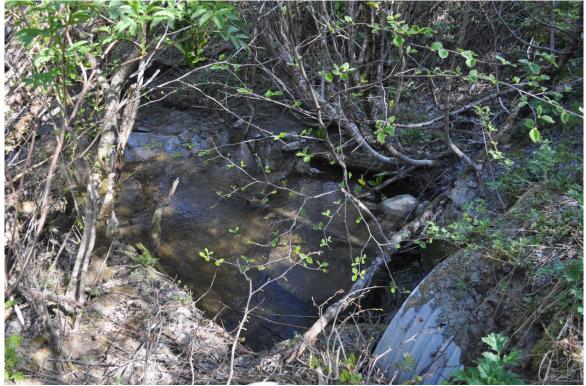
Concrete, re-bar, and other non-natural materials in stream. 5/13/2020

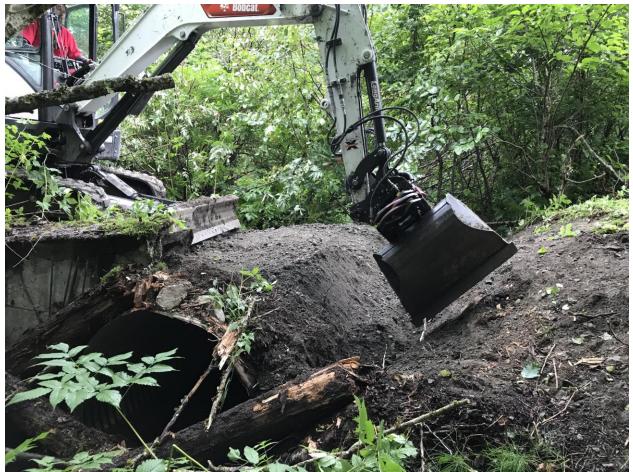
Our excavator was equipped with an articulating bucket which made removal of material around the culvert much easier and quicker than it would have been with a traditional digging bucket

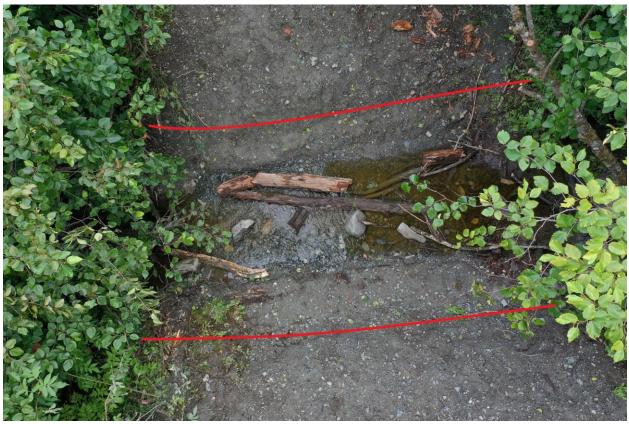
Newly-constructed channel showing designed bank-full limits (red lines)
