# **Aquatic and Riparian Habitat Rehabilitation, Enhancement, and Mitigation in Haines, Alaska: Inventory and Case Studies**

**Ben Kirkpatrick, Mark Sogge, and Stacie Evans  
Takshanuk Watershed Council  
HC 60 PO Box 2008  
Haines, Alaska 99827**

**June 2021**

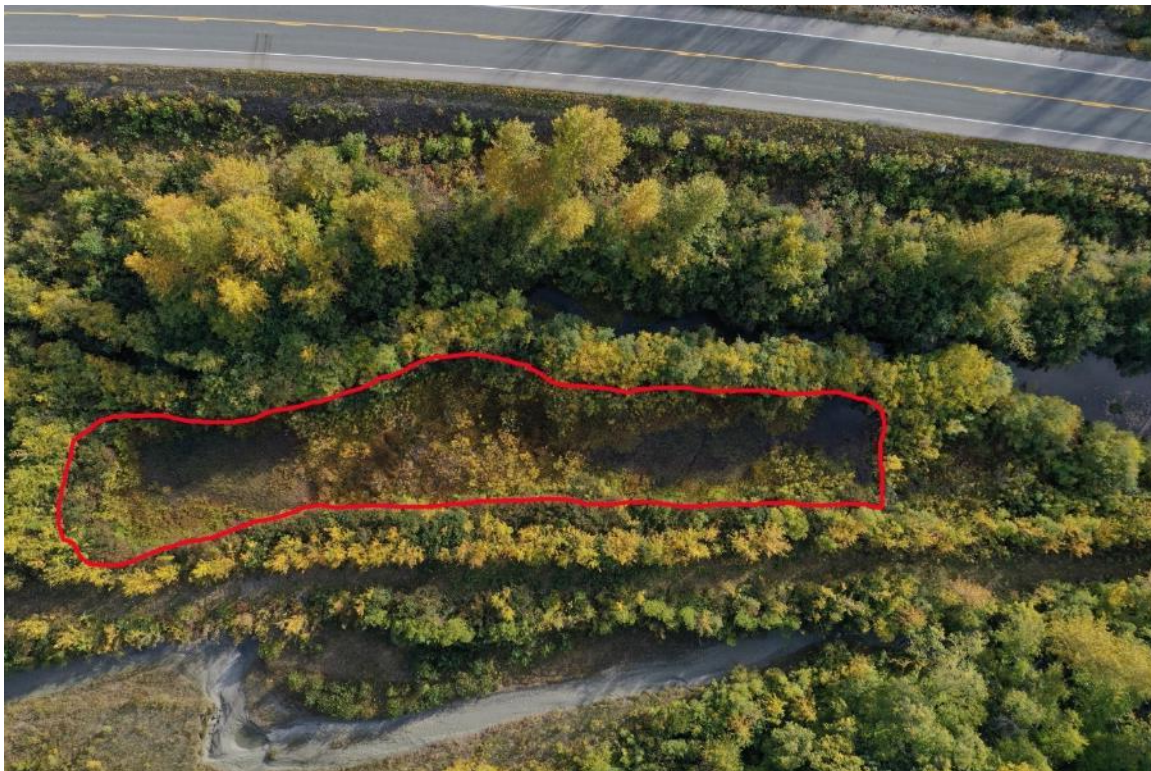
The monitoring by ADF&G found that approximately 50% of the designed wetland area was dry, unvegetated, elevated roadbed and channel berm. The site visit conducted in 2020 did not delineate the wetlands, or measure the total area. However, it was observed that a substantial area of wetlands persists, and this area appears to be larger than the area designated wetlands in the design documents.

Aerial view of 29 Mile Wetland (WT-3), 2020

- Institute a long term (once every 10 years) monitoring schedule of this wetlands to document the persistence and evolution of a created wetlands.

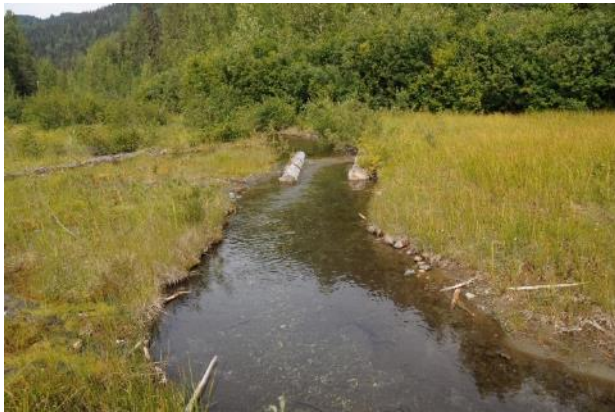
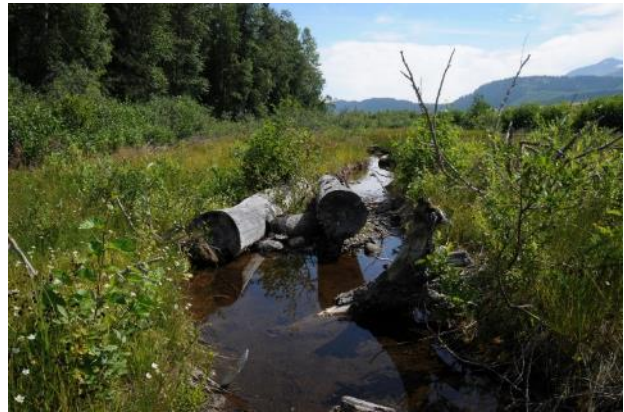
37 Mile wetland channel with backwater structure (left). Backwater structure floated out of place by flooding caused by beaver dam (right). 2020.

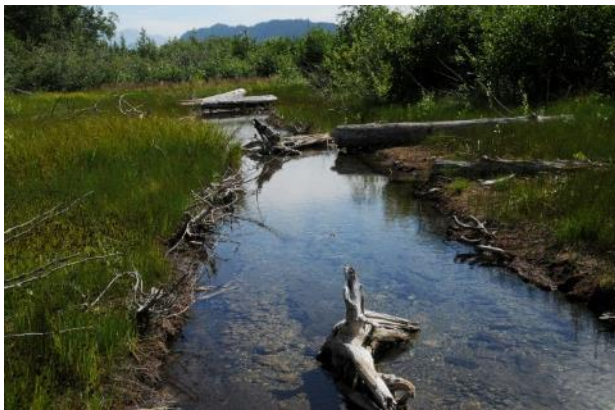
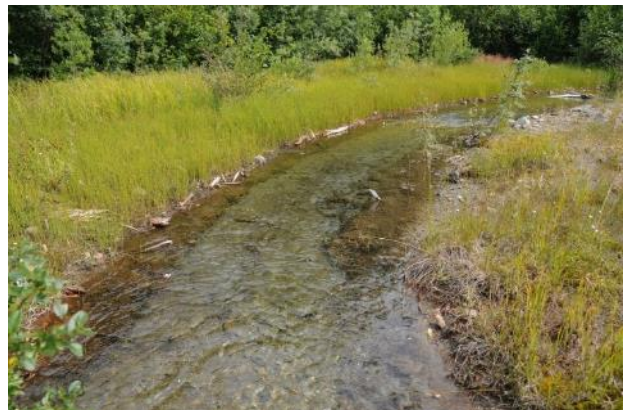
37 Mile wetland channel with woody debris (left). 37 Mile wetland channel with decomposing hay bale banks visible (right). 2020

- In similar conditions, use coir logs instead of hay bales to construct the banks of streams within created wetland complexes.
- In similar conditions, keep created channel narrow in hopes of forcing ground water to saturate the wetland soils.

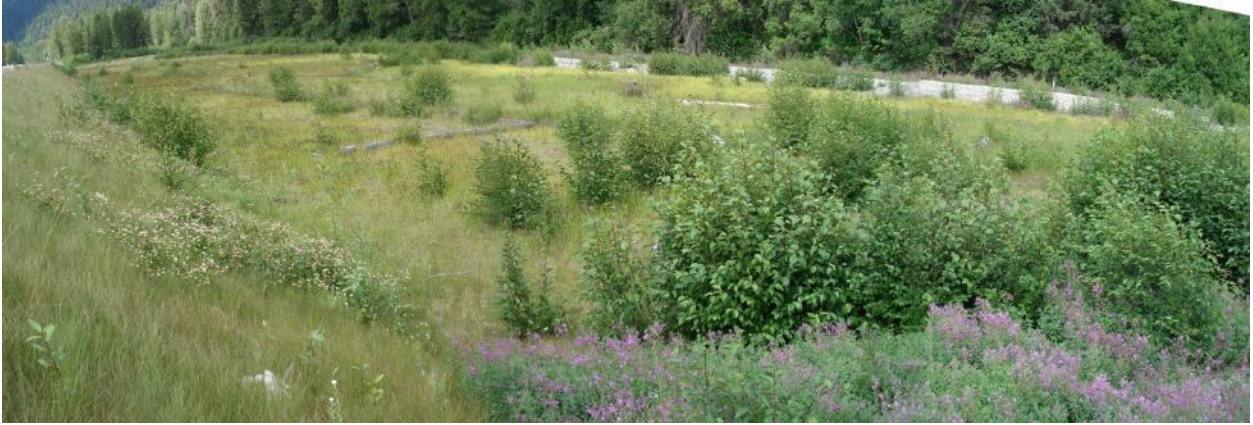
Non-wetland vegetation has begun encroaching in parts of 37 Mile Wetlands (WT-5) in 2006.

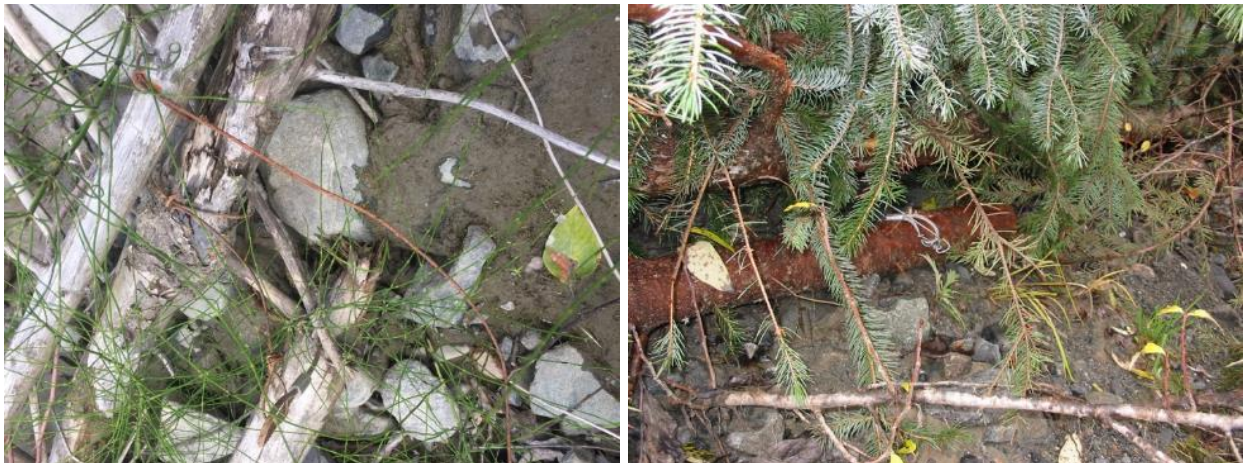
By 2020, the spruce trees are rotting away, but vegetation is becoming established.

Cables holding spruce trees in 2020 (left) and 2003 (right).

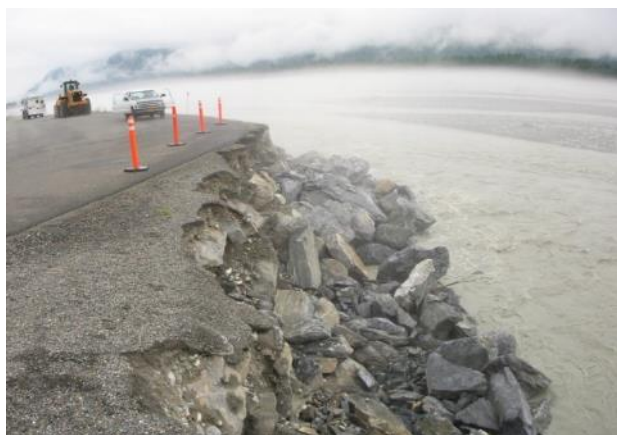
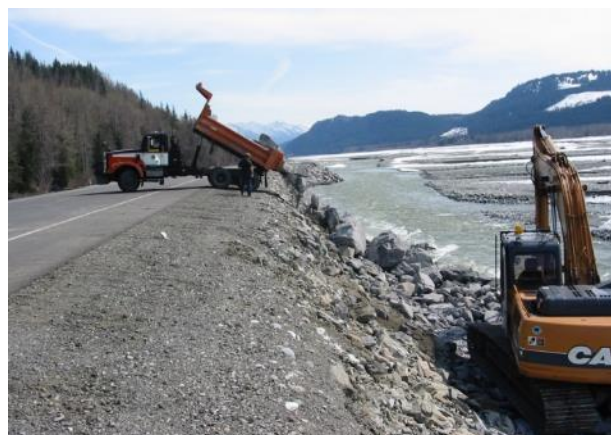
During construction in 2000 (left). Parts of the revetment start to unravel by 2003 (right).

- Monitor this revetment regularly to document aggradation and potential failure.
- Future monitoring of the associated mitigation projects should continue to determine efficacy.

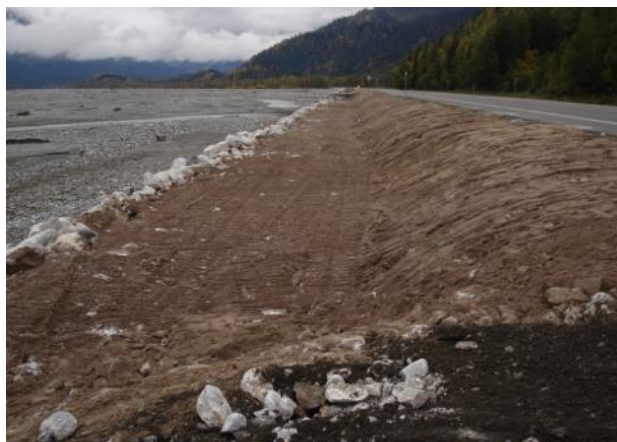
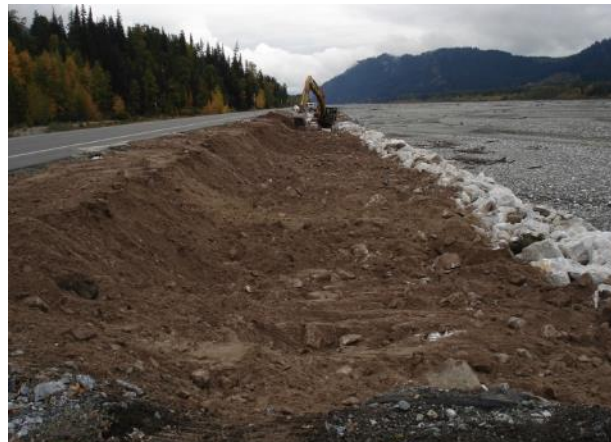
Road failure began in 2004 (left) and reconstruction was started that year (right).

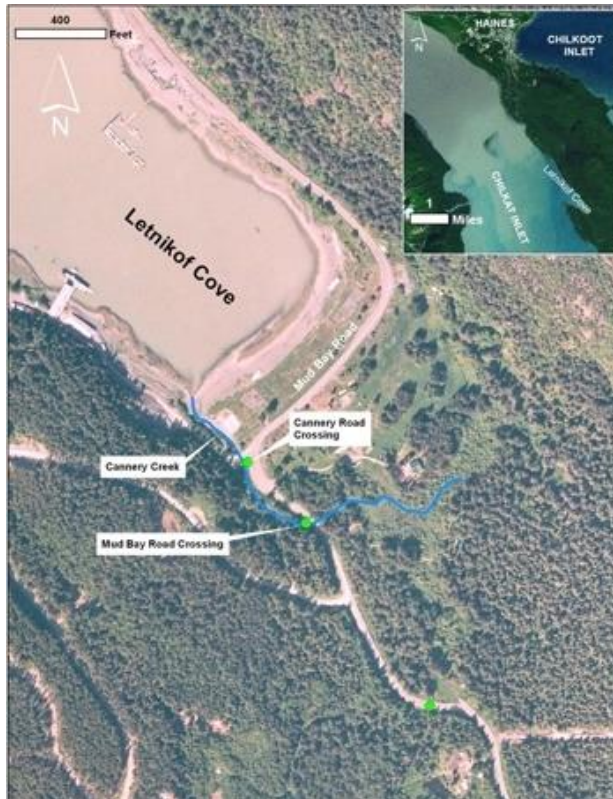
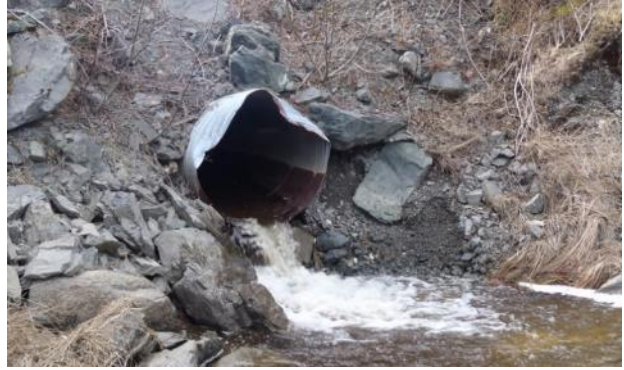
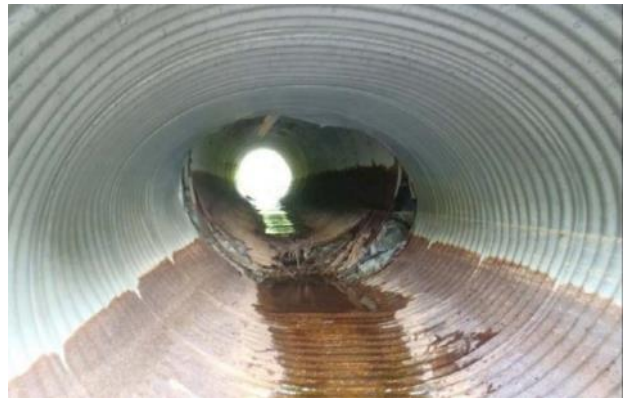
**Project Need:** Failing perched 48" culvert restricts fish passage to high tides only. This stream provides important rearing habitat for coho salmon from the adjacent Chilkat River.

Cannery Creek drainage area (left). Old culvert outlet and inside drainage in 2013 (right).

- continue to monitor
- replace the upstream culverts that are inadequately designed.

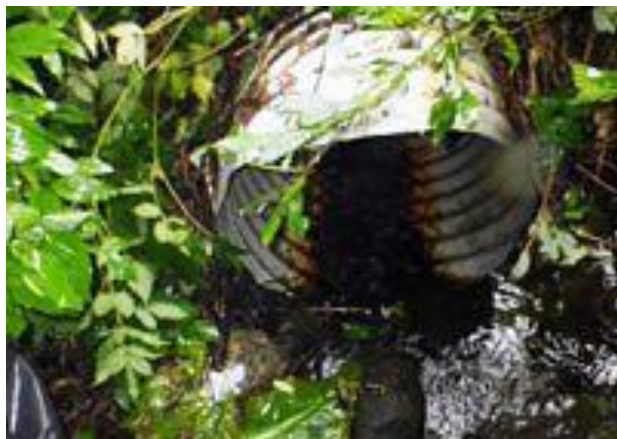
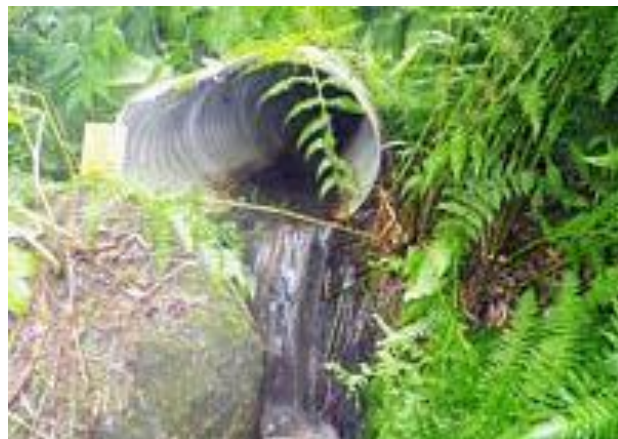
Culvert inlet and outlet before replacement on August 8, 2012.

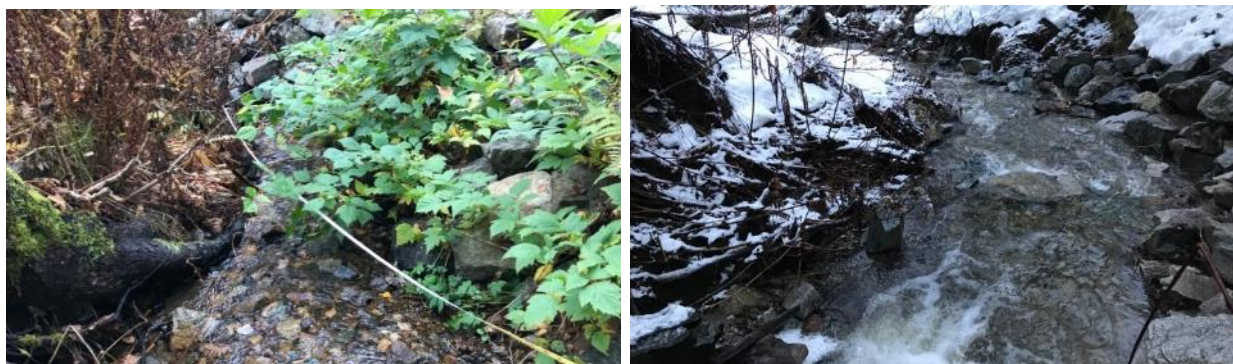
Outlet channel being encroached by riprap in October 2020 (left). After flood event in December 2020 (right).

- continue to monitor access channel and baffles.
- ensure riprap does not obstruct channel and compromise fish passage.

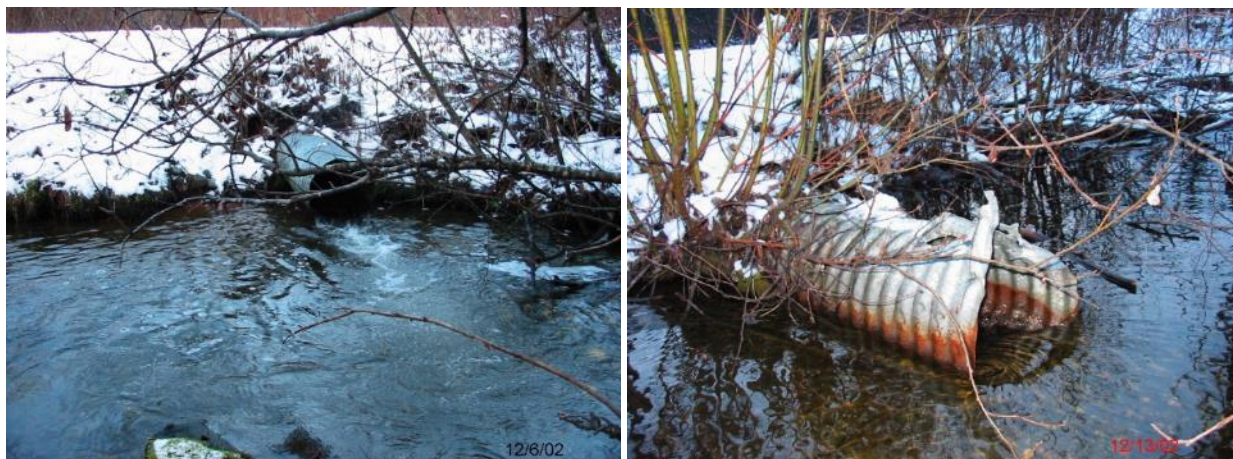
Culvert outlet (left) and inlet (right) before replacement in 2002.
