Kelsall Tributary Restoration

Post-construction Monitoring Report - September 27, 2022

Project Goal: Improve fish passage on an unnamed tributary of the Kelsall River (AWC listed stream 115-32-10250-2143-3001) by raising the water surface to resolve a perched culvert.

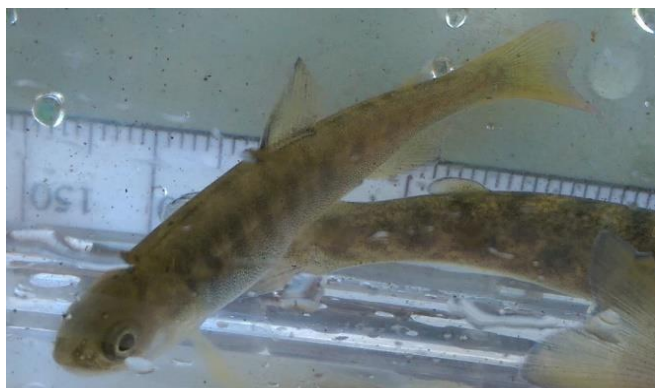
Above: coho juvenile captured on 9/12/20.

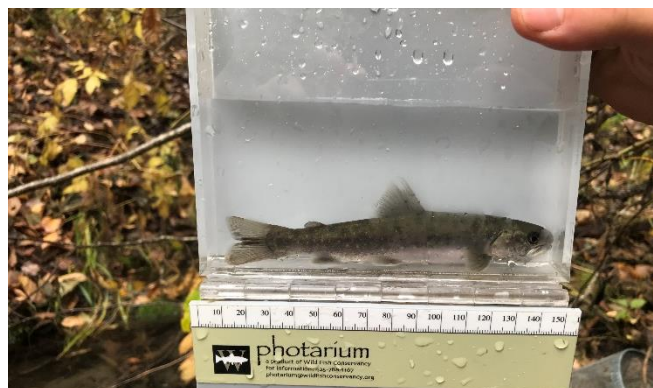
Above right: Dolly Varden juvenile captured above culvert on 9/21/22 indicating upstream fish passage through the culvert.

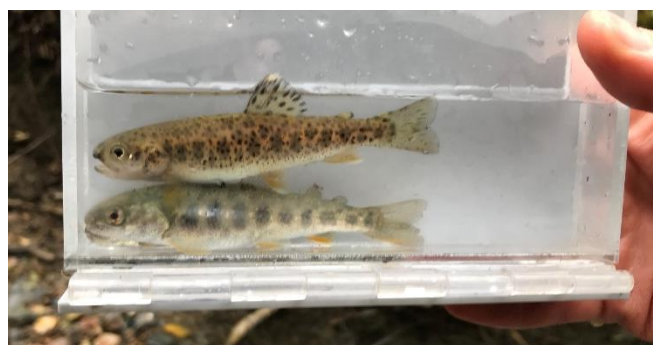
Below right: cutthroat and Dolly Varden juveniles captured above first weir log on 9/21/22 indicating upstream fish passage over all weirs.

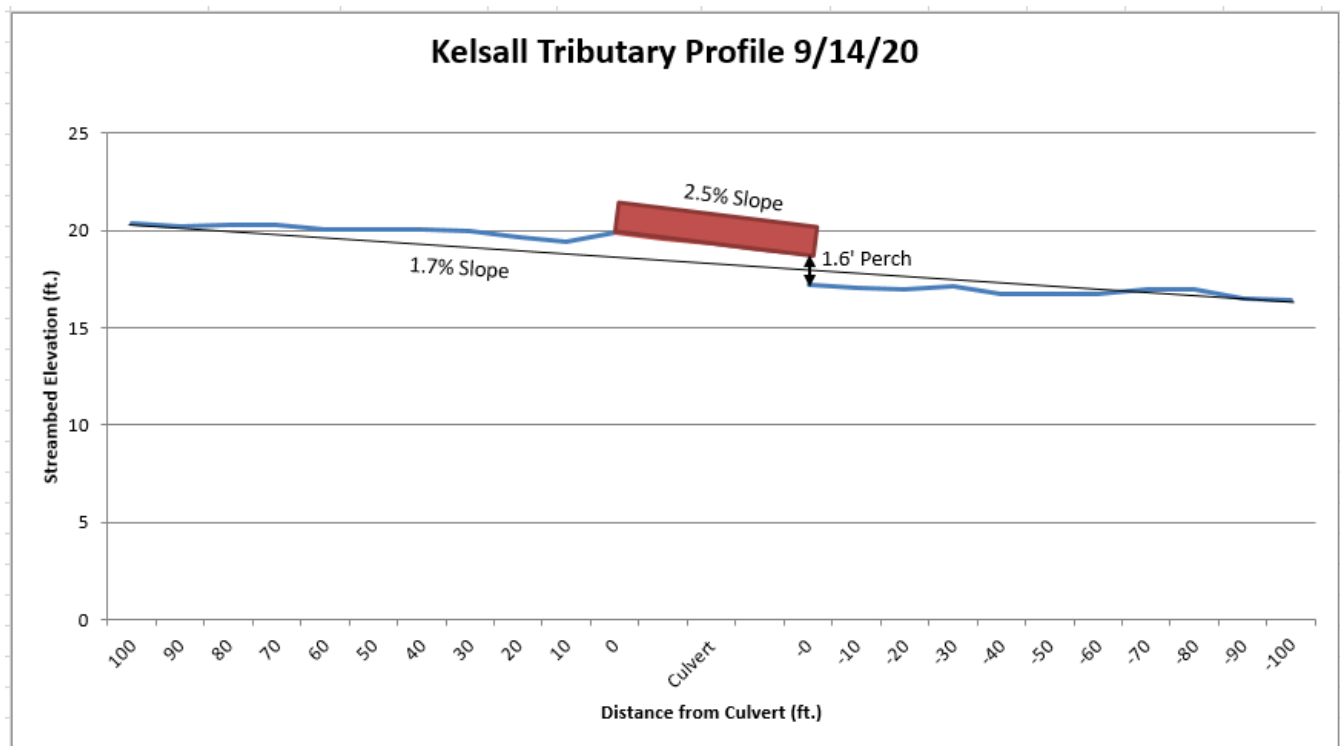
Longitudinal Streambed Profile Survey: Streambed elevation was measured at estimated center of thalweg on 9/14/2020 before step pools were built. This survey was repeated to monitor post construction changes.
