# **Aquatic and Riparian Habitat Rehabilitation, Enhancement, and Mitigation in Haines, Alaska: Inventory and Case Studies**

**Ben Kirkpatrick, Mark Sogge, and Stacie Evans  
Takshanuk Watershed Council  
HC 60 PO Box 2008  
Haines, Alaska 99827**

**June 2021**

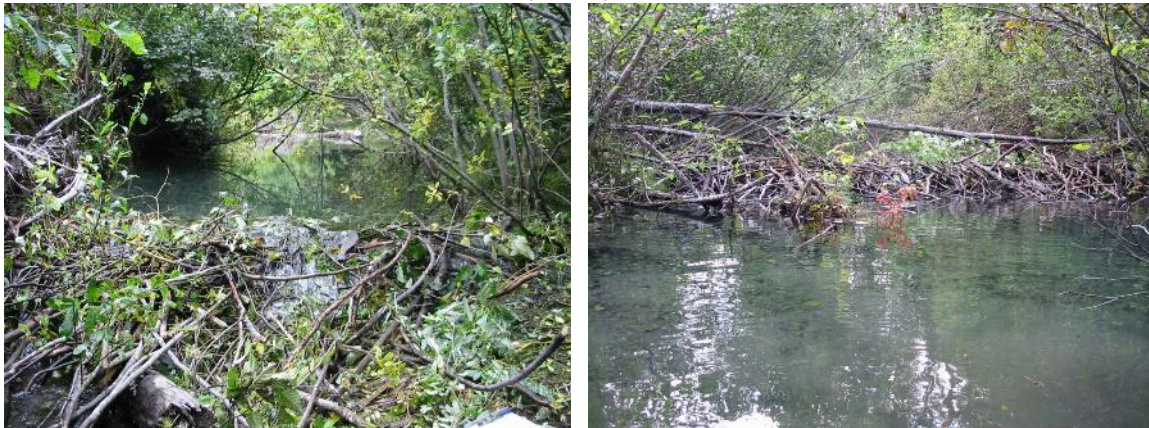
The monitoring found that the stream was initially well utilized by rearing salmonids. However, beavers constructed a dam near the lower end of enhanced stream reach and blocked all fish passage for a few years. The removal of a gate blocking an upstream culvert in 2002 allowed the flood flows of the Klehini River to enter the system and resulted in the beaver dam washing out in 2004.

Beaver dam in CH-8, 2002 (left) and 2003 (right).

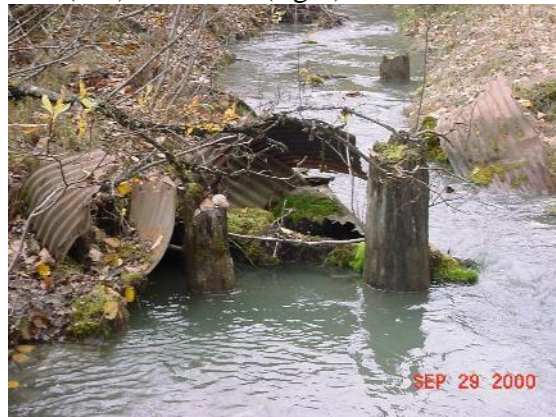
Debris in CH-8 in 2000; just upstream of culvert.

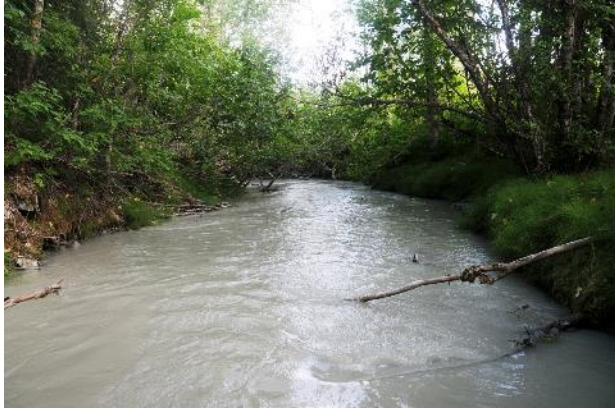
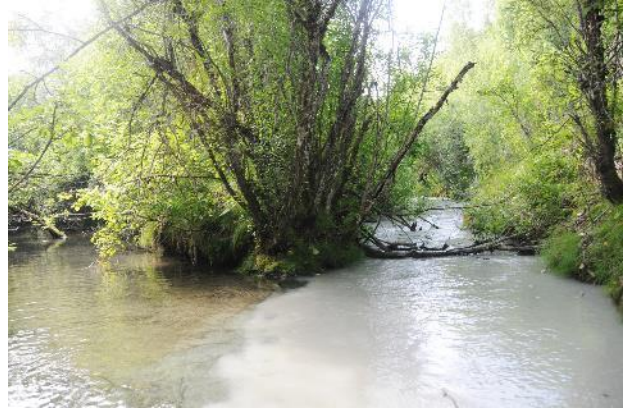
water was flowing down the entire 29 Mile Creek. Under these conditions, the productivity of the stream was reduced in comparison to a clear, ground water fed system. It was not possible to see if the increased flows had resulted in a more complex stream environment.

Klehini River flows in 29 Mile Creek (CH-8) on (left) and confluence of 29 Mile Tributary (CH-9) and 29 Mile Creek (right) on July 31, 2020.

- Monitor the long-term flow of the Klehini River and 30 Mile Creek adjacent to the culvert entrance. In addition to opening water flow to periodically provide increased scouring, also allow clear flows when possible to flush out excess silt currently present in 29 Mile Creek.

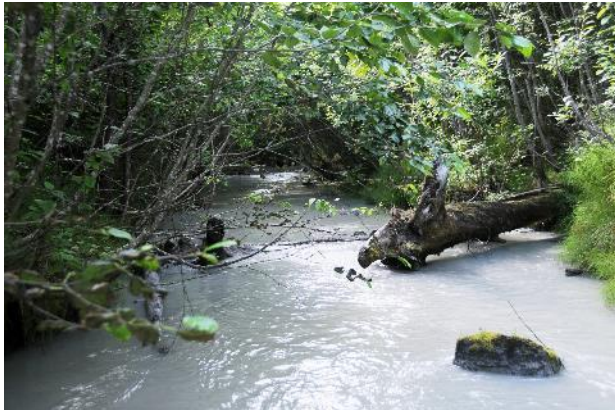
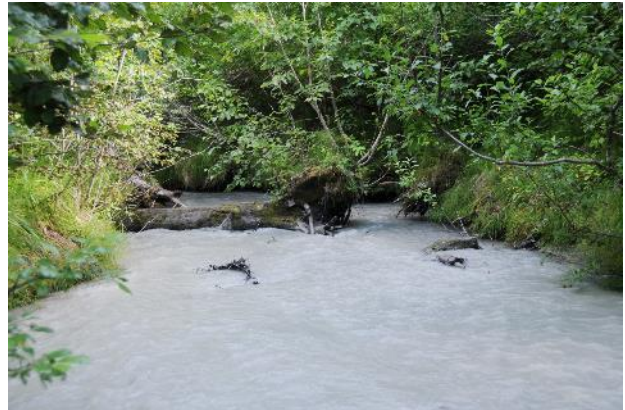
Large woody debris in 29 Mile Creek on July 31, 2020.

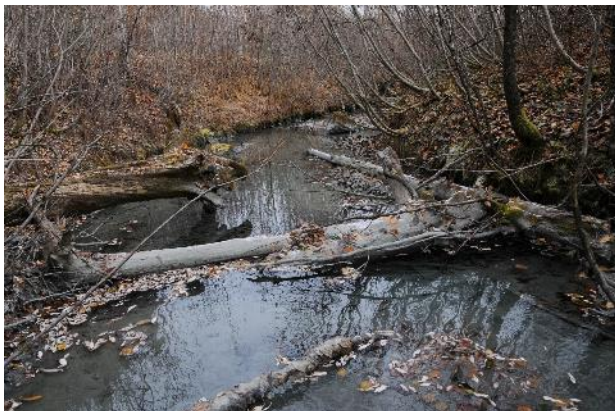
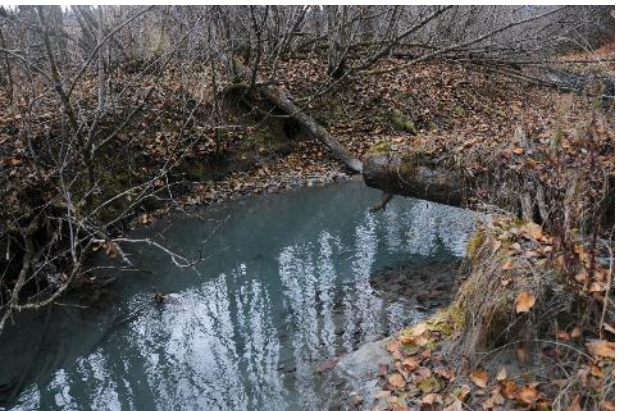
29 Mile Creek (CH-8) large woody debris (left) and scoured pond (right) on October 24, 2020.

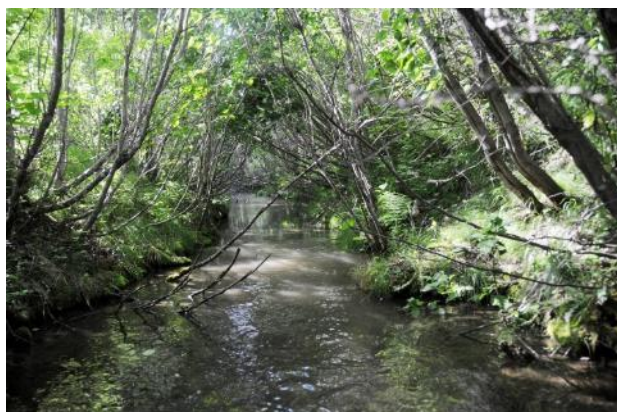
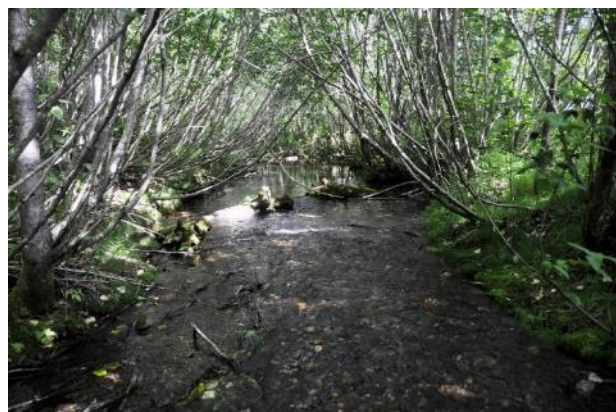
The monitoring found that the stream and pond were utilized by rearing salmonids. A small number of spawning salmon were observed in the pool soon after construction. The stream has good flow and contributes clear groundwater to 29 Mile Creek. The riparian area of the stream has vegetated well, with near 100% cover. The pond perimeter is also well vegetated. The installed large woody debris has persisted and continues to influence stream morphology.

Typical stream section (left) and large woody debris in 29 Mile Creek Tributary (CH-9) (right) in 2020.

- Although it would be difficult to complete, the addition of more large woody debris would increase the complexity of the stream channel.

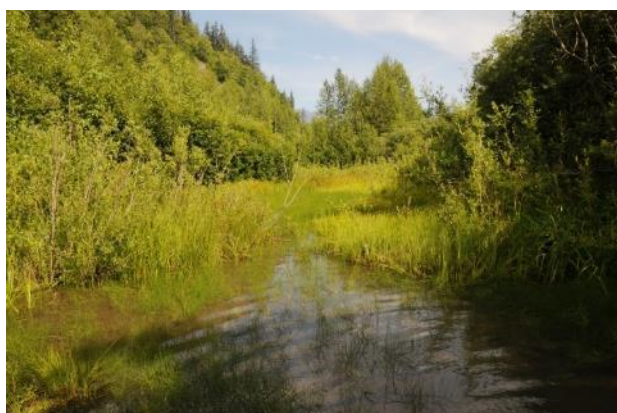
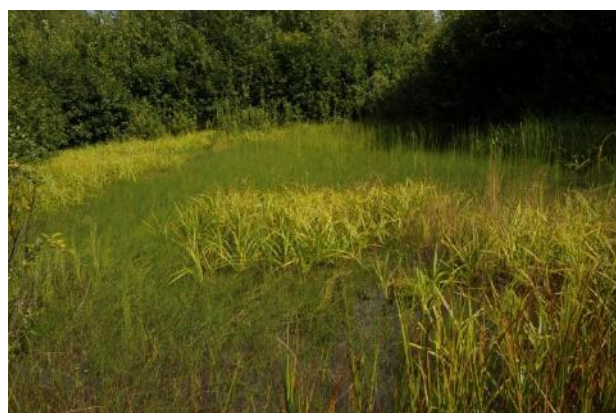
The monitoring by ADF&G found that approximately 50% of the designed wetland area was dry, unvegetated, elevated roadbed and channel berm. The site visit conducted in 2020 did not delineate the wetlands, or measure the total area. However, it was observed that a substantial area of wetlands persists, and this area appears to be larger than the area designated wetlands in the design documents.

29 Mile Wetland (WT-3) from the east end (left) and west end (right) in 2020.

- Institute a long term (once every 10 years) monitoring schedule of this wetlands to document the persistence and evolution of a created wetlands.

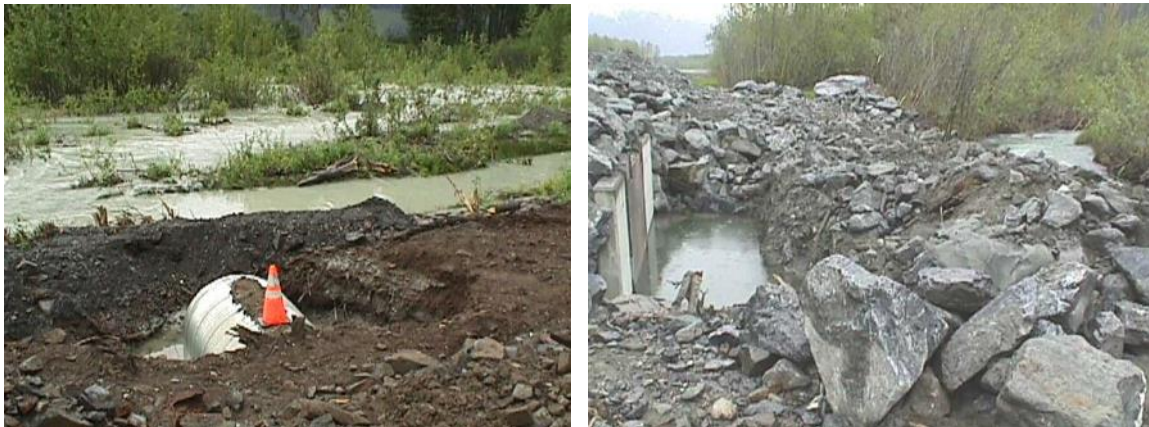
**Note:** ADOT/PF Haines maintenance personnel do not know what happened to the steel head-gate. It is not on site and not in the ADOT/PF yard.

CV4 Inlet in April 1999 (left) and May 2000 (right).

- Locate or fabricate a replacement gate for the culvert headgate.

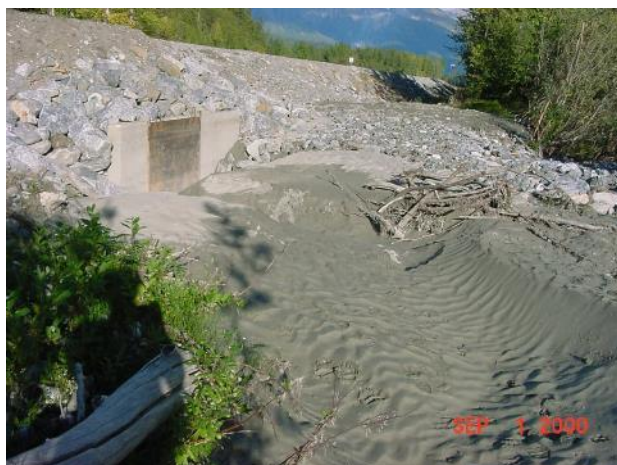
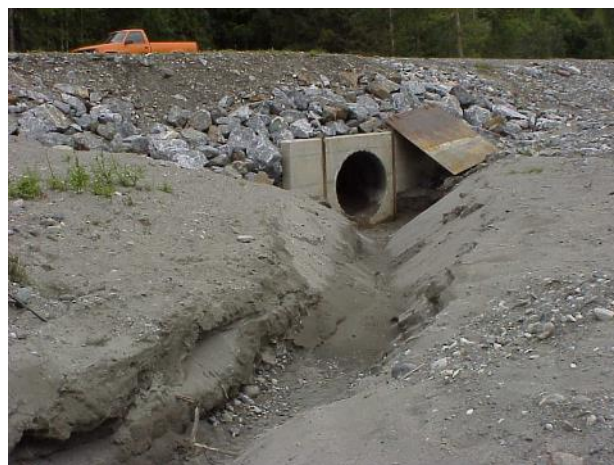
CV4 Inlet in September 2000 (left) and July 2002 (right).

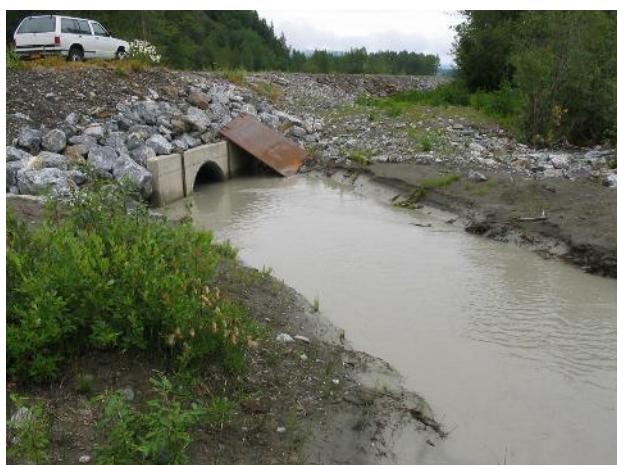
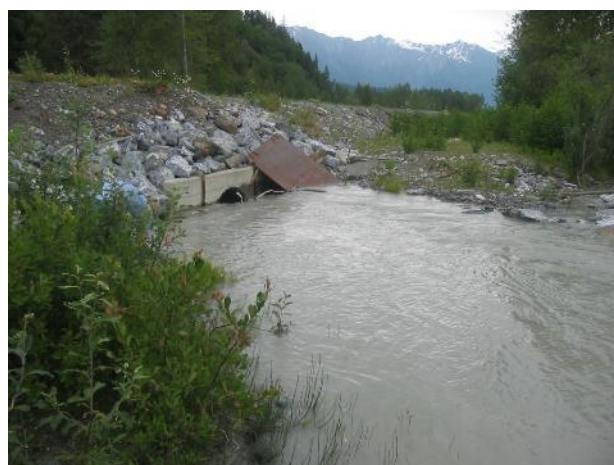
CV4 Inlet in June 2004 (left) and 2005 (right).

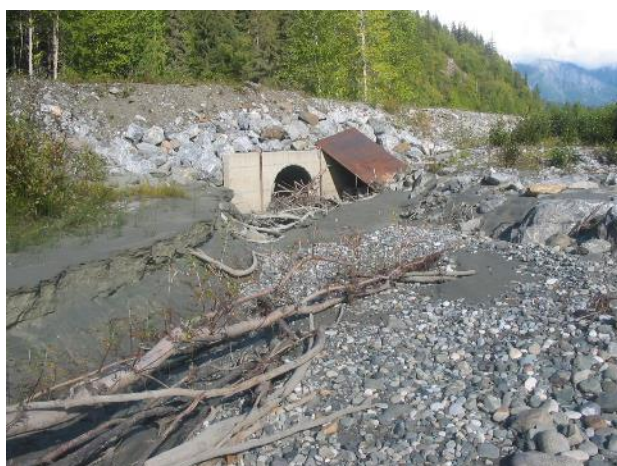
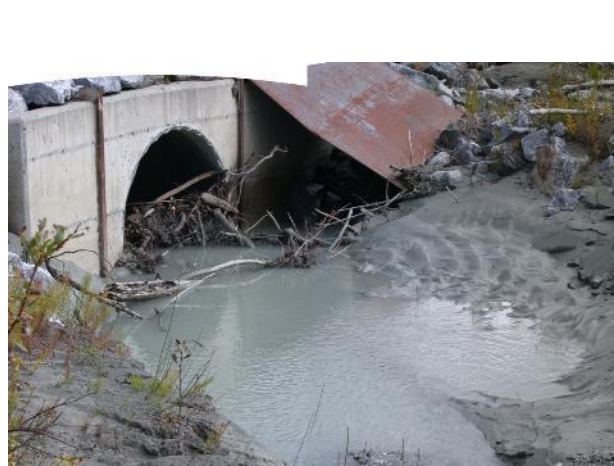
CV4 Inlet in September 2004 (left) and 2006 (right).

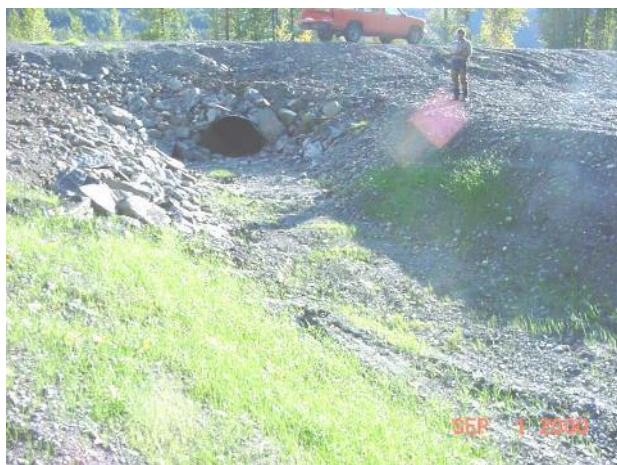
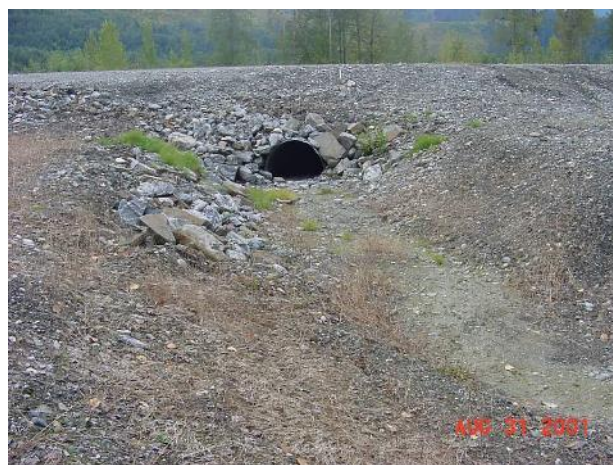
CV4 outlet in September 2000 (left) and August 2001 (right).

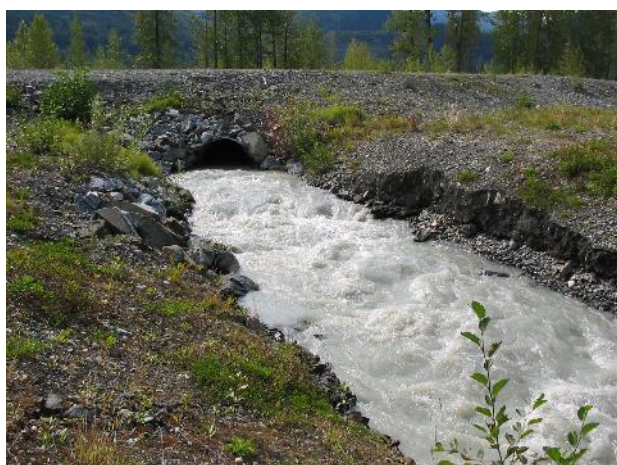
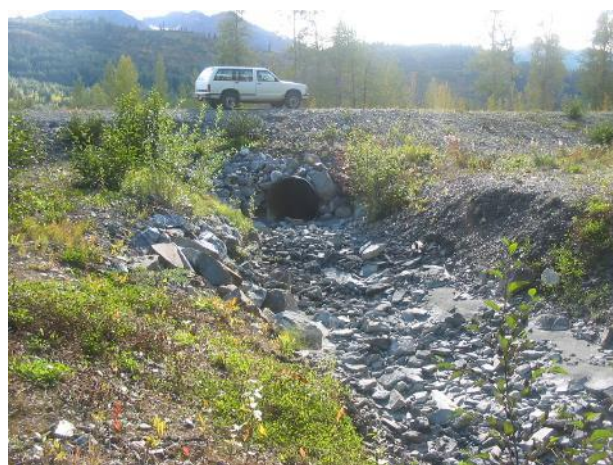
CV4 outlet in August 2004 (left) and September 2005 (right).

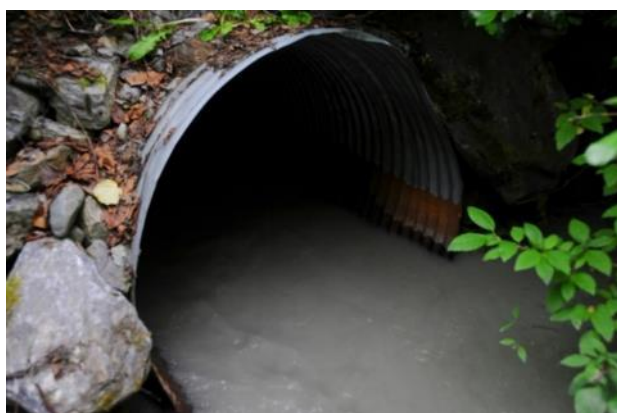
CV-4 outlet (July 31, 2020) (left). Klehini River deposited gravels and woody debris at the CV-4 inlet (right). Note the vertical steel rail for the steel plate headgate (October 17, 2020).

- Secure funding that will allow for the removal and replacement of the headgate as required.
- Secure the commitment of a competent non-profit organization to annually monitor the 29 Mile Creek and determine when the gate should be opened and closed. This organization could also oversee or complete the excavation required to open up the channel to the inlet of the culvert.
- Monitor the long-term flow of the Klehini River and 30 Mile Creek adjacent to the culvert entrance. In addition to opening the headgate to

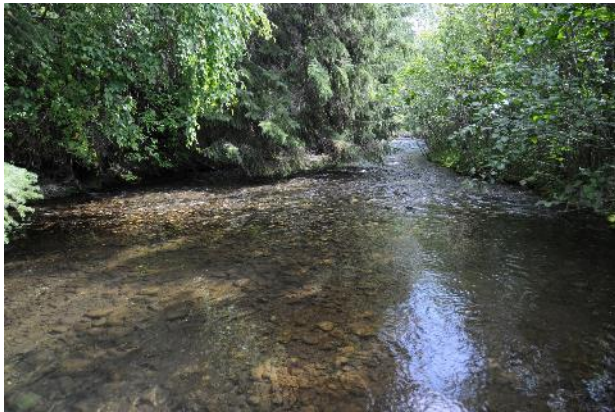
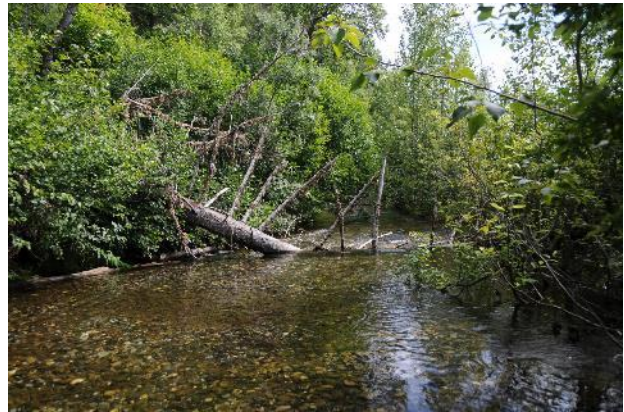
CH-13 glide to riffle transition, undisturbed bank on the left side (left). Post construction large woody debris from existing north bank (right). 2020.

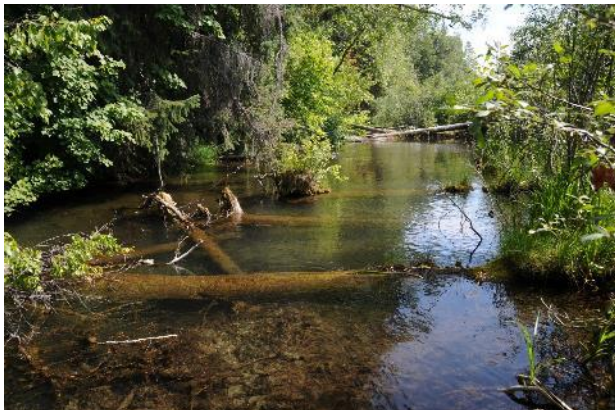
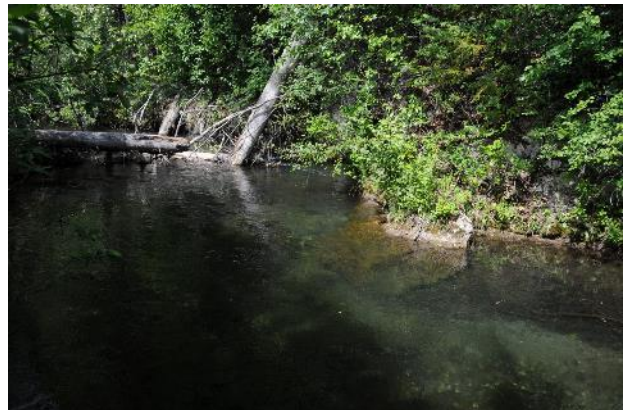
CH-13 large woody debris installed in a pool along the constructed right bank (left) and north bank (right). 2020.

- Periodically monitor the constructed channel to assure that large trees falling from the hillside have not blocked the stream flow and caused it to avulse into the adjacent wetlands.

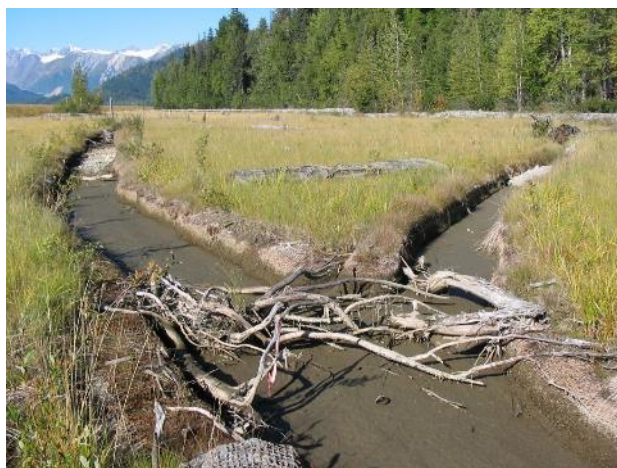
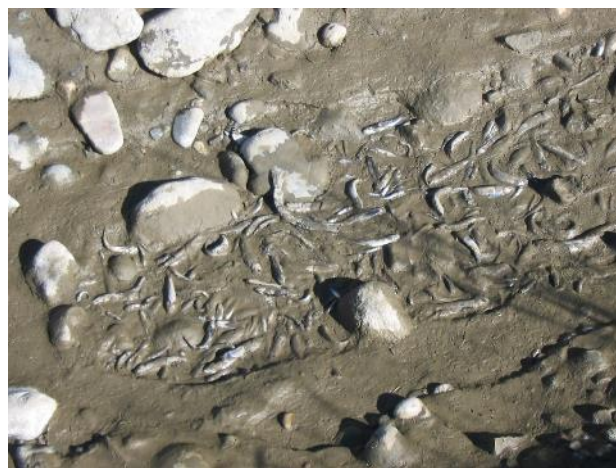
Wetland Channels occasional go dry as in September 2004.

- In similar conditions, keep wetland and stream gradient near zero to encourage emergent wetland flooding and prevent the channels from serving as dewatering structures.
- Maintain backwater structures as necessary to avoid lowering the wetland water table.

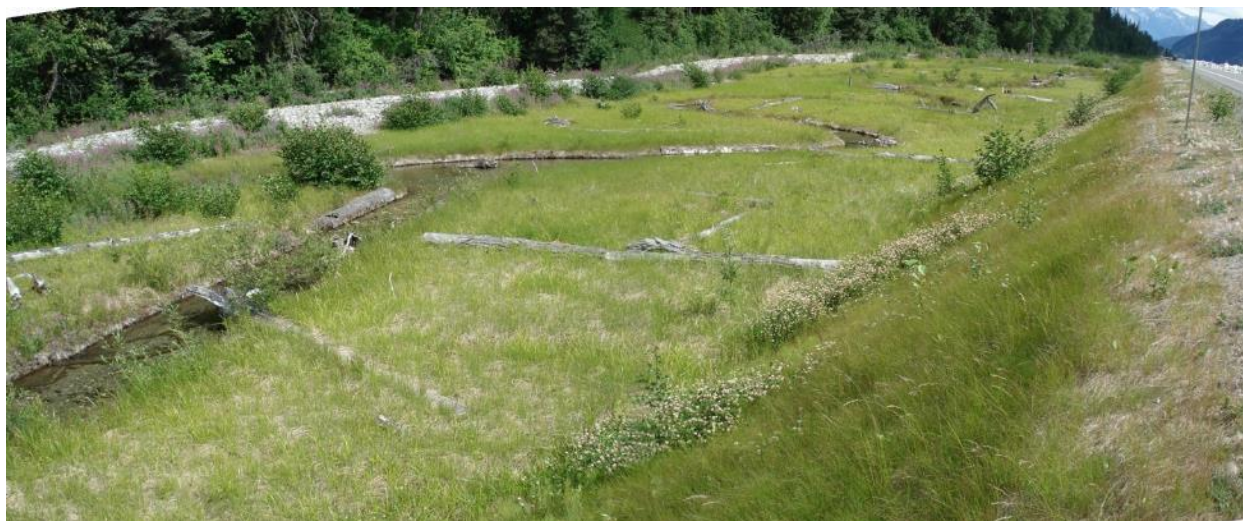
WT-5 has become established by 2006.

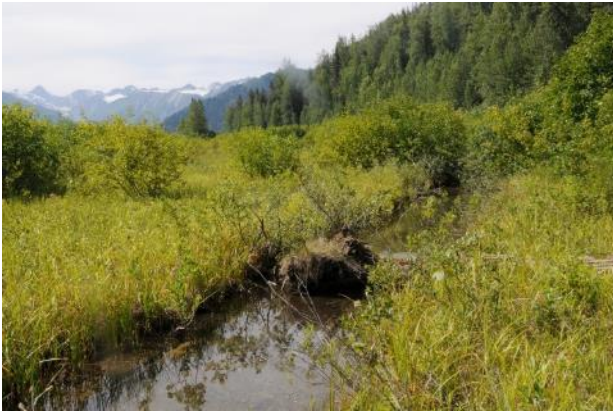
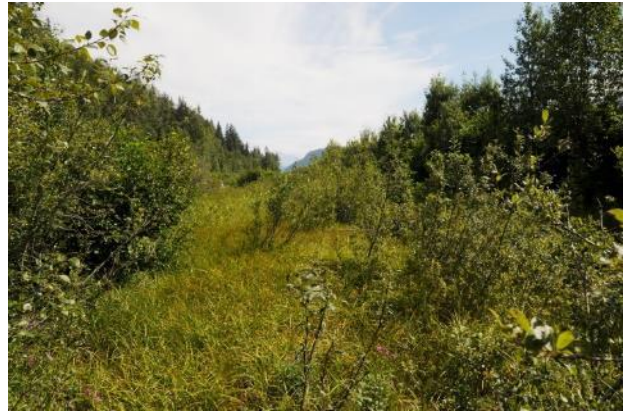
Wetland cell WT-5A (left) and WT-5B (right) in 2020.

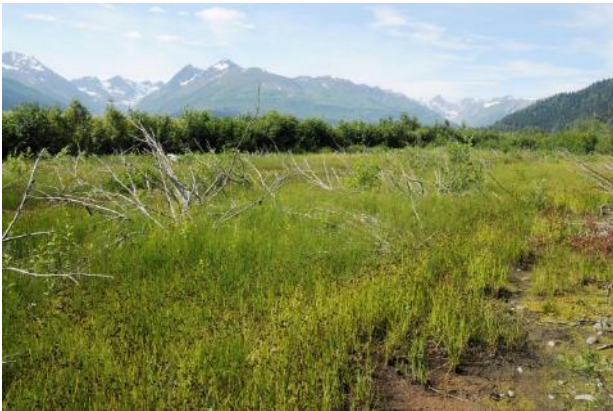
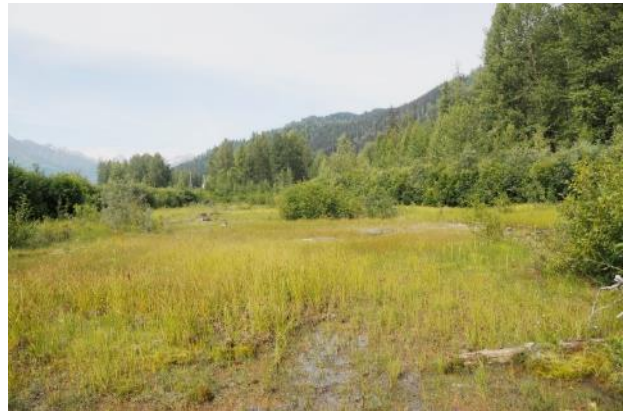
Wetland cell WT-5C with dead willows, indicating change in hydrology (left) and Wetland cell WT-5D (right) in 2020.

- In similar conditions, create smaller wetland cells and terrace each of the cells to be relatively flat. Control the water elevation within each cell by matching the desired wetland water elevation

- In similar conditions, minimize the width and depth of streams created within the wetland complex to avoid creating channels that may dewater the wetland.

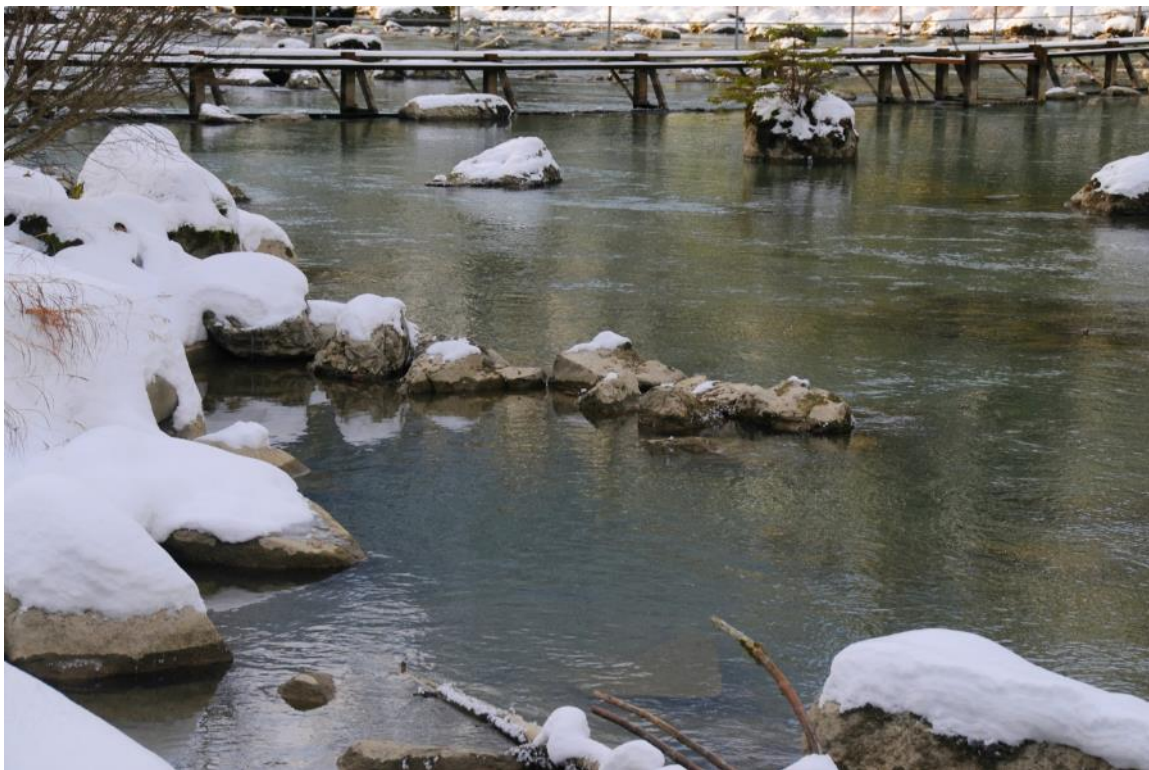
Vane above Chilkoot weir, 2020.

- Continue monitoring the conditions of the vanes to assure that the rock remains in place and the vanes function as designed.

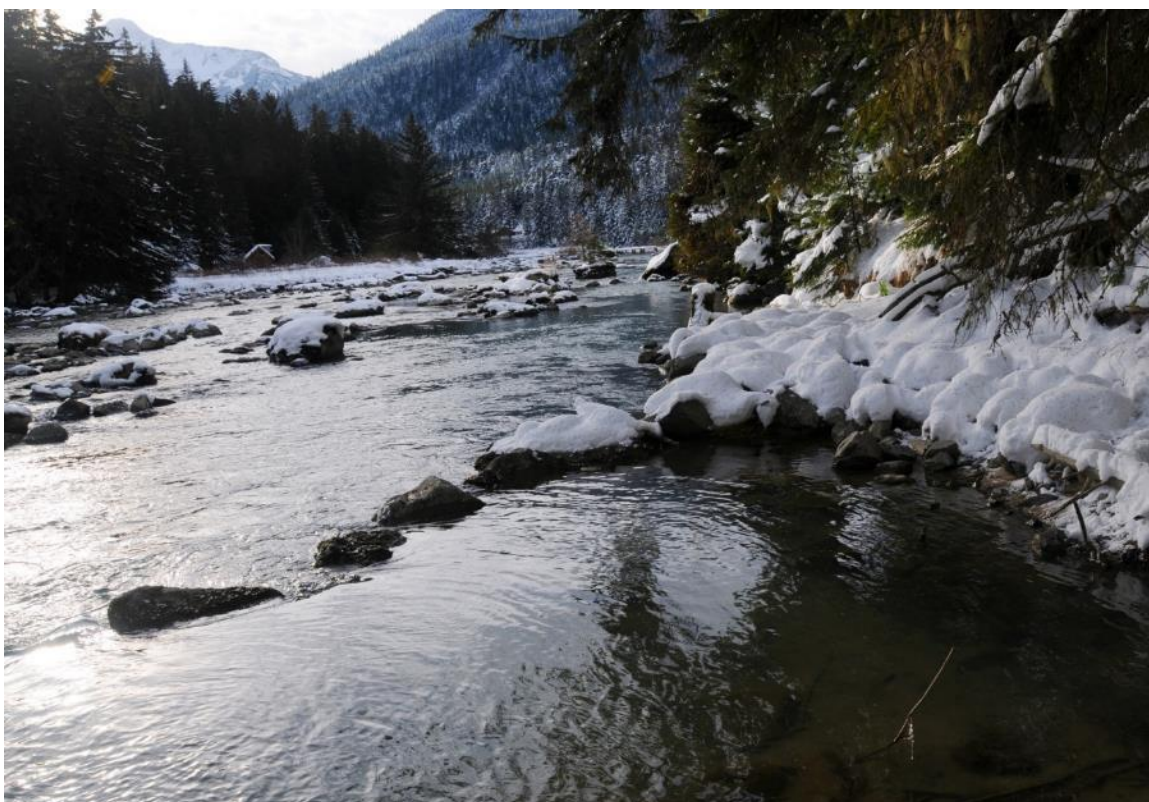
Vane and rock bench below the spruce tree, 2020.

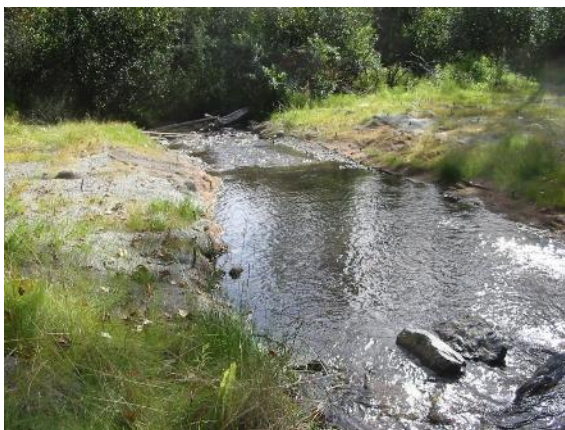
McKenzie Creek in 2002.

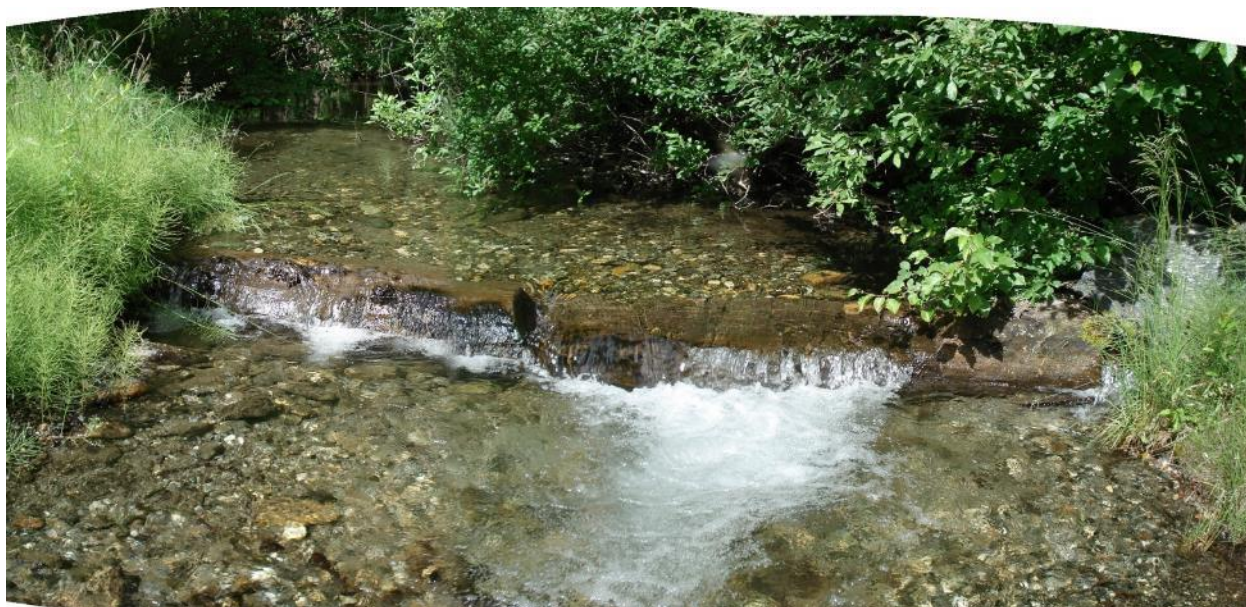
MacKenzie Creek in 2006.

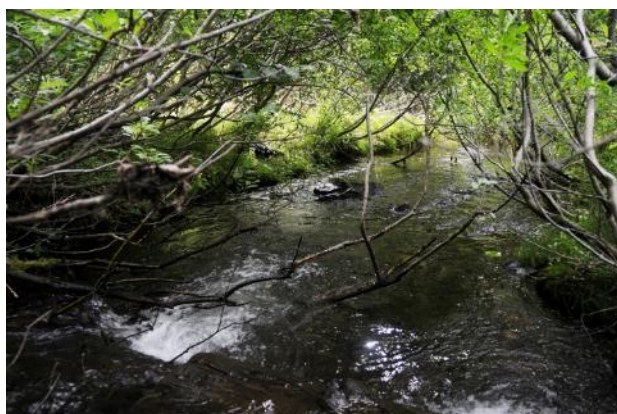
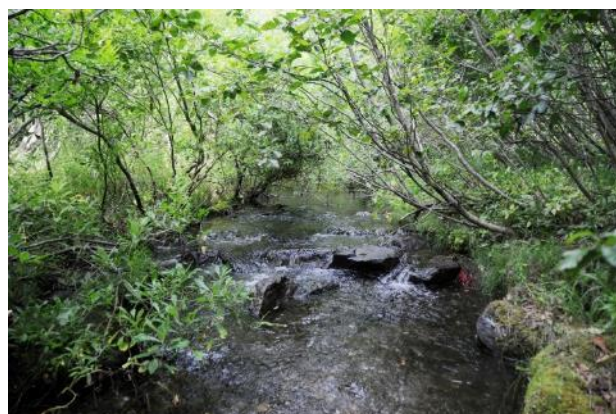
Restored McKenzie Creek channel from upstream end, sill log in the foreground (left). Restored McKenzie Creek channel from downstream end, placed boulders in the foreground (right). 2020.

- Create a steam crossing structure for 4-wheelers to use as an alternative to driving through the stream.

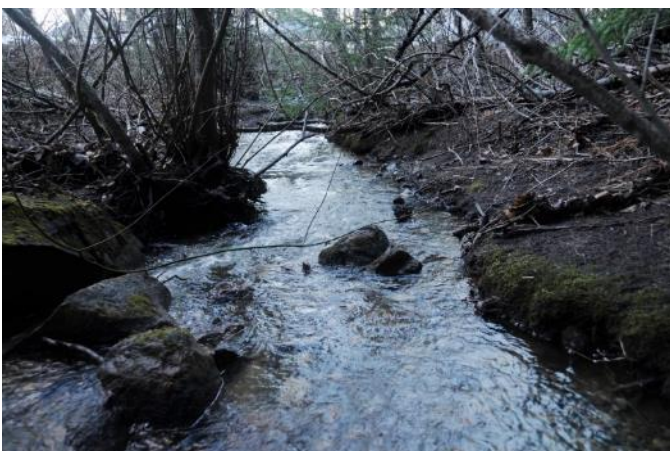
Upper reach of restored stream channel in 2020.

- Place some new large woody debris in the broad, midstream section of the restored stream. This wood should be placed to use water flows to recreate a narrower channel that will provide fish passage during low water.
- Seed the stream with new spawning gravel by periodically placing the gravel at the outlet of the culvert on 6<sup>th</sup> Avenue and allowing it to move downstream during high water events.
- Replace large wood as needed to recreate the structures necessary to form pools where designed. Use wood large enough to withstand flood flows.

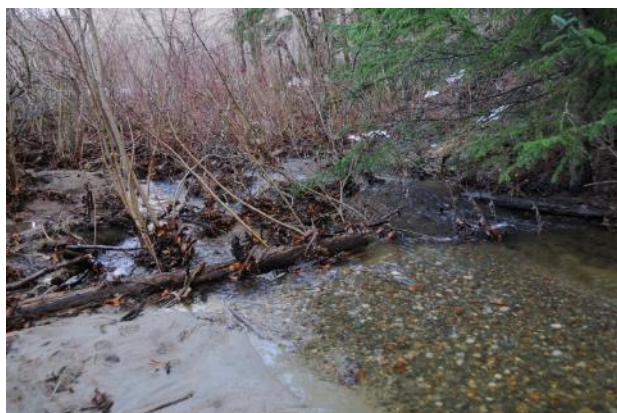
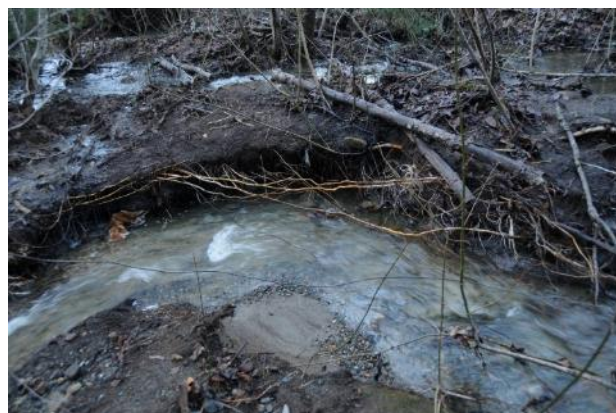
Lower section of restored channel from midstream, post 2020 historic flood event (left). Mid-channel bend with recent erosion (right).

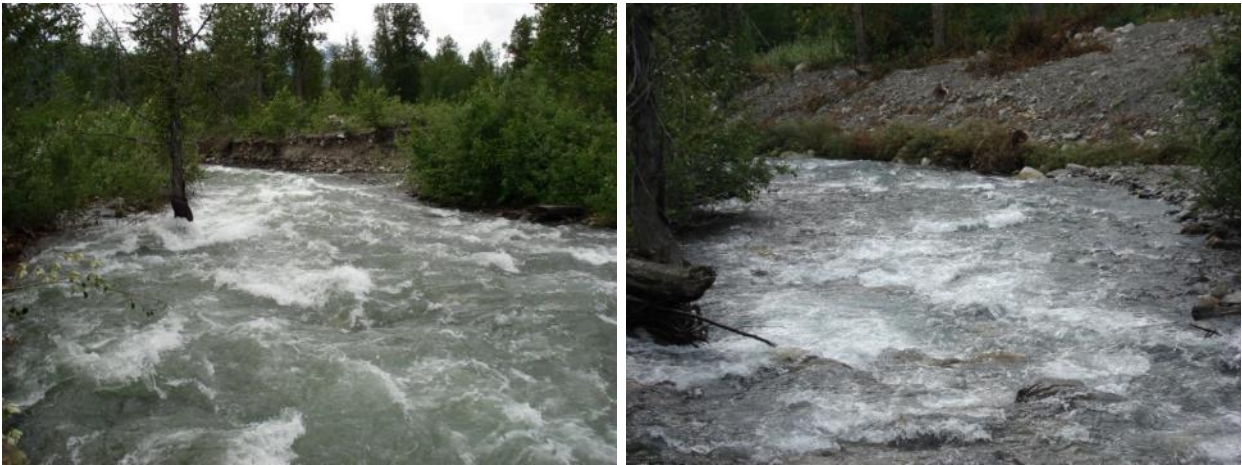
Compromised bank before (left) and after (right) stabilization.

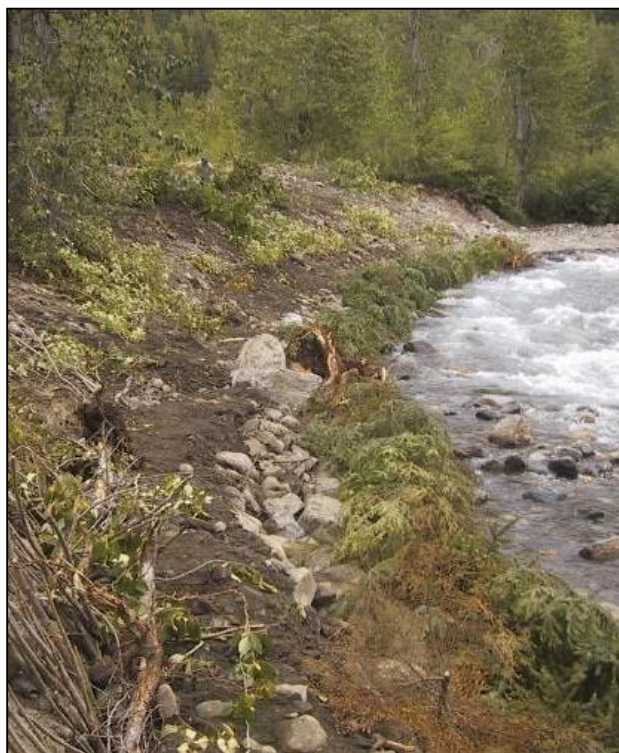
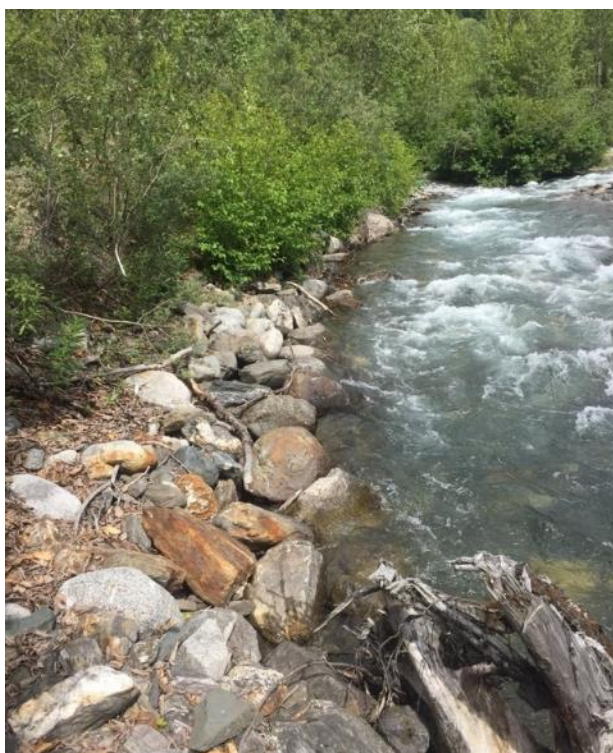
Revetment with graded slope, toe rock, willow poles, root wads, and spruce trees in July 2008 (left). Revetment in 2020 (right).

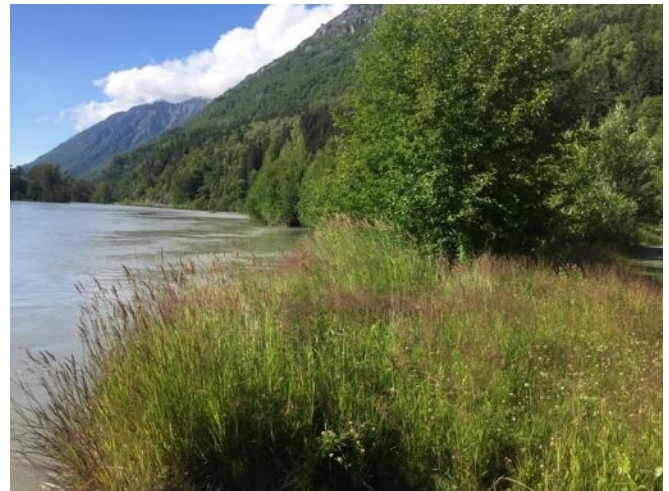
Revegetated site in 2020.

- All commercial raft take out sites need to be monitored and remediated if necessary.

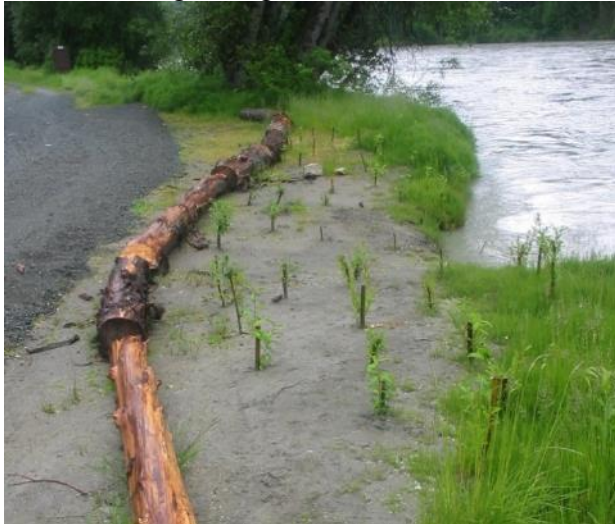
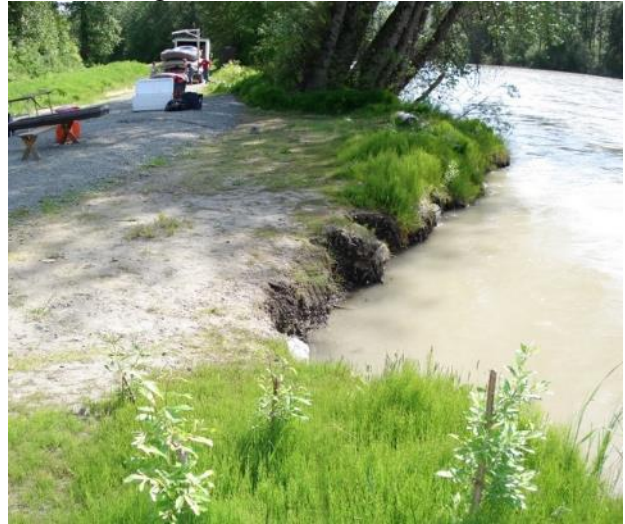
Willow cuttings growing in June 2005 (left). Some willows are surviving in June 2006, but bank continues to unravel (right).

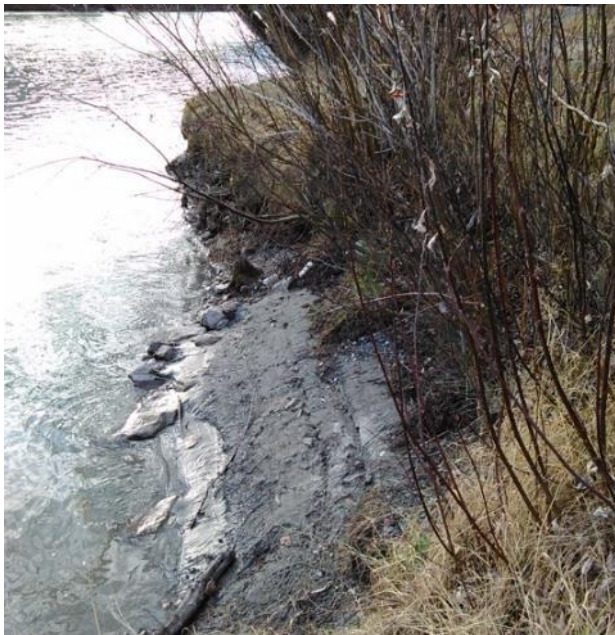
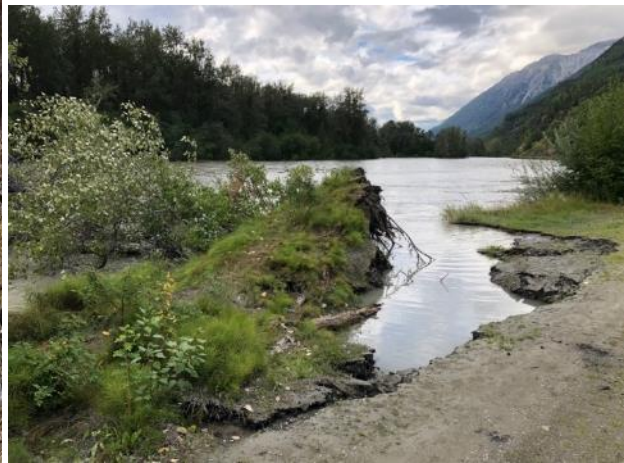
Site in November 2015 (left). Site in September 2018 after tree fell (right).

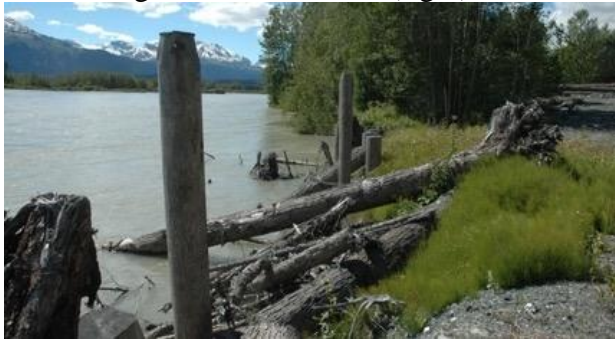
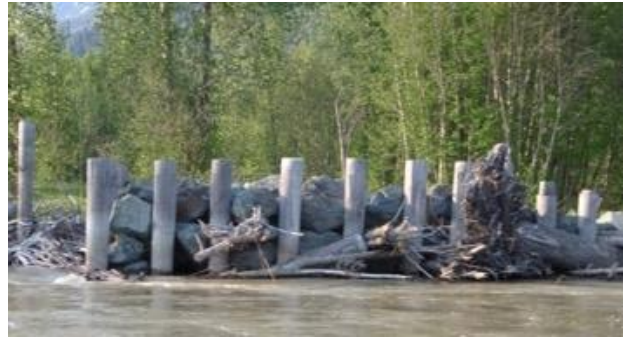
Type I & II structures shortly after construction in April and July 2008 (left). By August 2009, some revegetation has started (right).

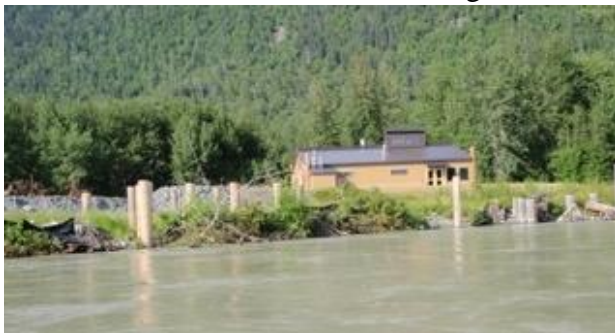
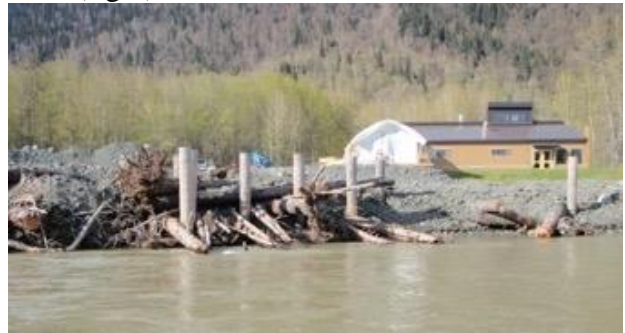
By July 2010, revegetation and site recovery has started (left). By May 2011, debris accumulation on structures and revegetation continue (right).

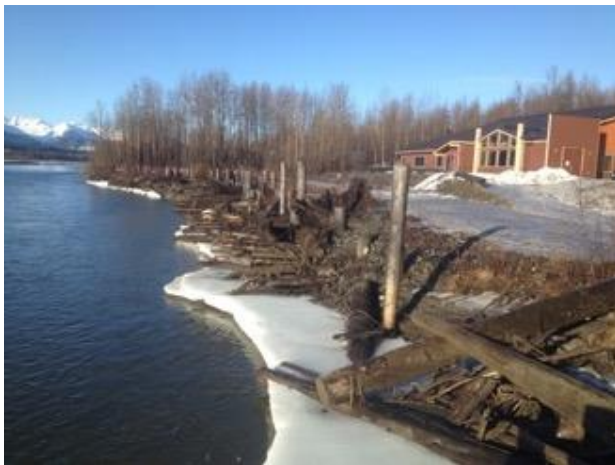
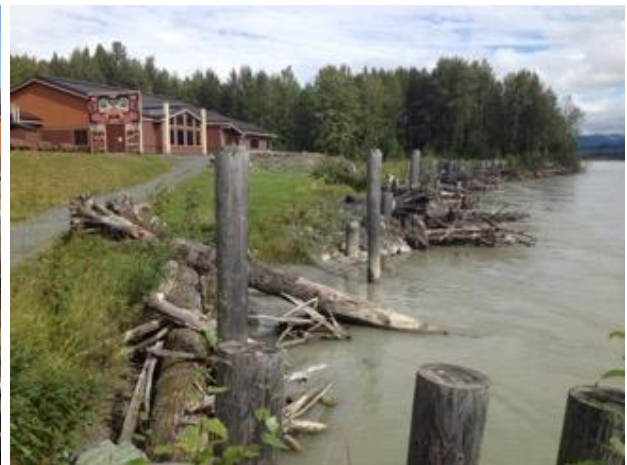
Revegetation progress in July 2016 (left). Use at the boat ramp inhibits revegetation (left).

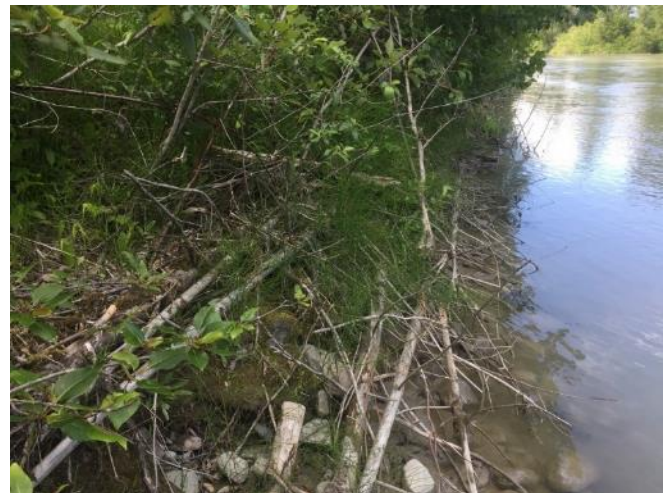
By 2020, the spruce trees are rotting away, but vegetation is becoming established.

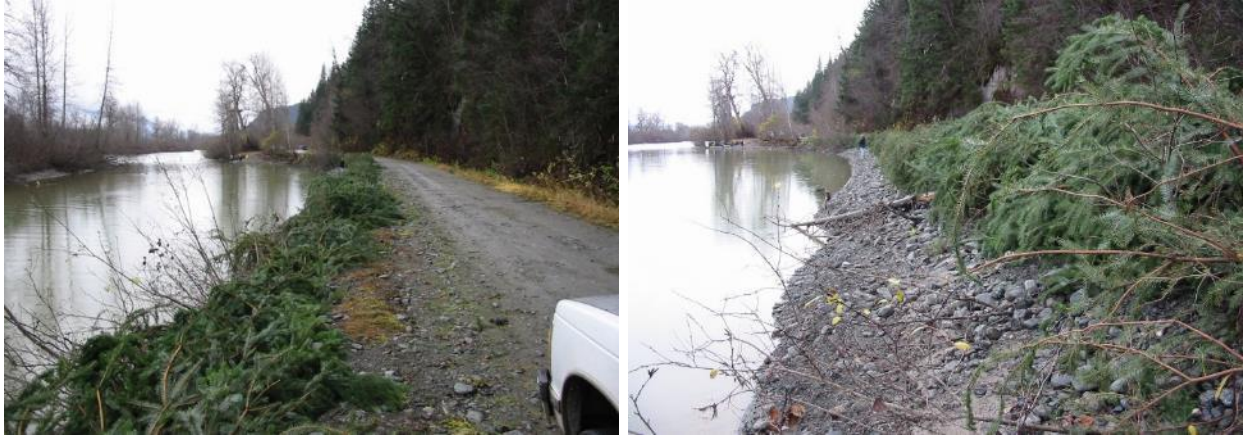
Streambank shortly after installation of spruce trees in October 2003.

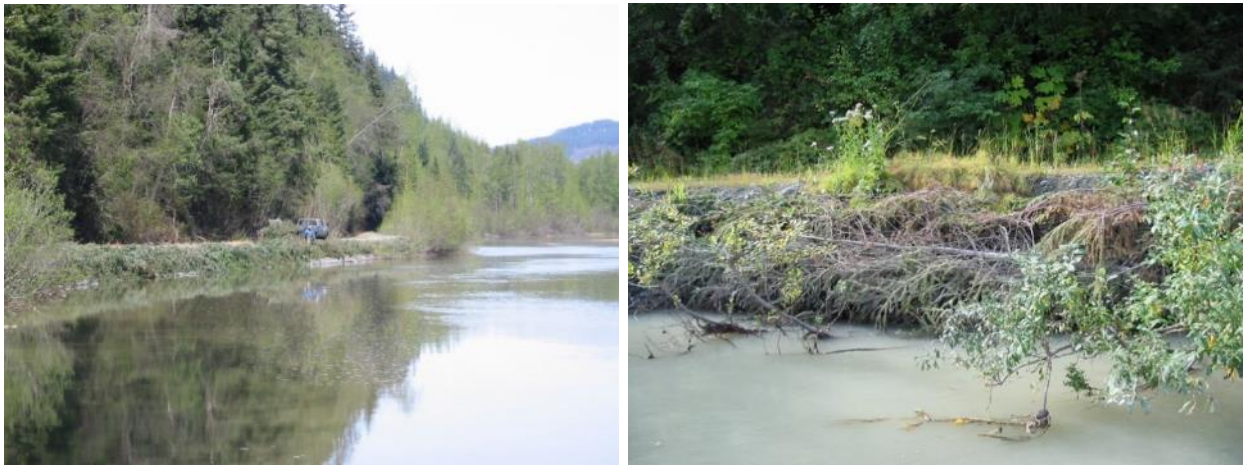
Streambank in May 2004 (left) and August 2004 (right). Spruce trees were defoliating by August.
