# **Aquatic and Riparian Habitat Rehabilitation, Enhancement, and Mitigation in Haines, Alaska: Inventory and Case Studies**

**Ben Kirkpatrick, Mark Sogge, and Stacie Evans  
Takshanuk Watershed Council  
HC 60 PO Box 2008  
Haines, Alaska 99827**

**June 2021**

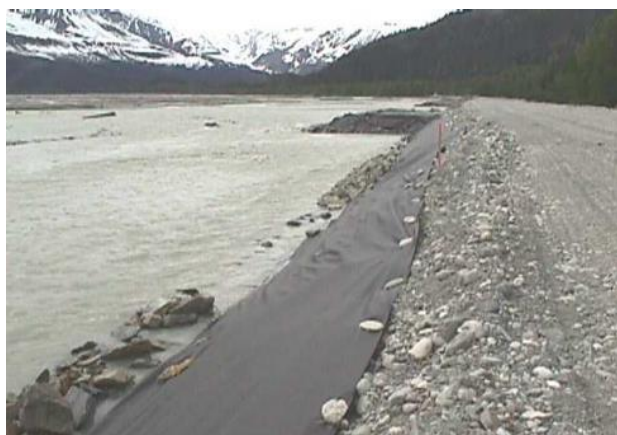
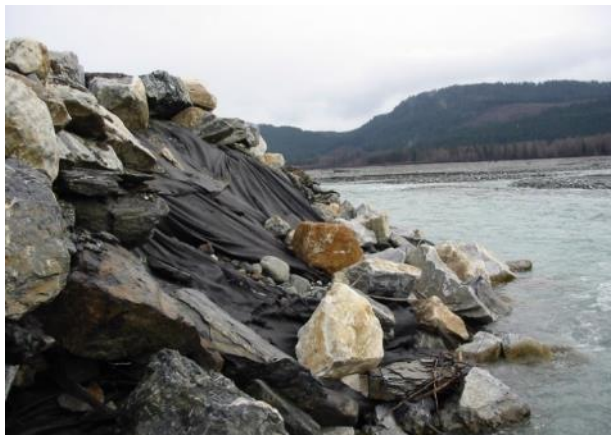
1. Original revetment was built, against ADF&G recommendations.
2. Additional reinforcement was placed upstream of 37 Mile Cr culvert
3. As revetment unraveled, additional riprap was placed at the toe.
4. Additional riprap was placed around the 37 Mile Cr culvert.
5. root wads with boles were embedded in revetment below 37 Mile Cr culvert.

During construction in 2000 (left). Parts of the revetment start to unravel by 2003 (right).

In 2003, 2004 and 2005 Fish Habitat permits were issued to repair the revetment and reestablish fish passage through the revetment.

- Monitor this revetment regularly to document aggradation and potential failure.
- Future monitoring of the associated mitigation projects should continue to determine efficacy.

- Continue to monitor fish passage through the revetment.

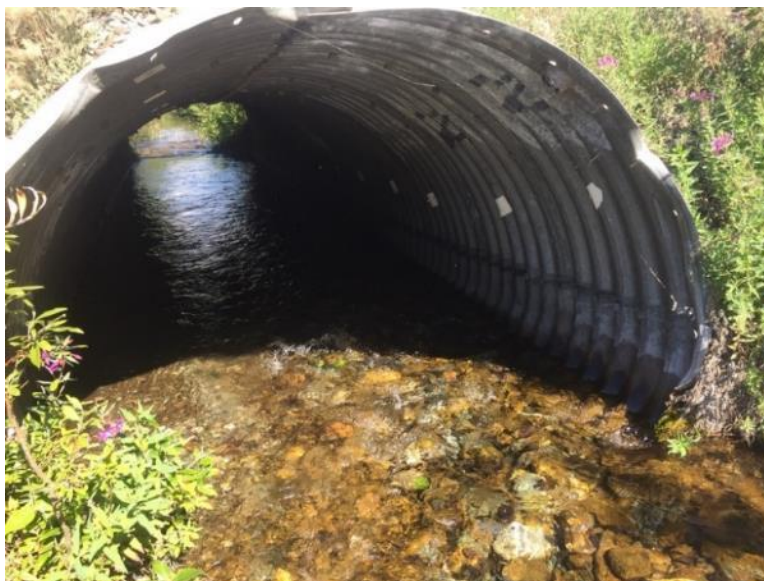
Culvert inlet in 2020.

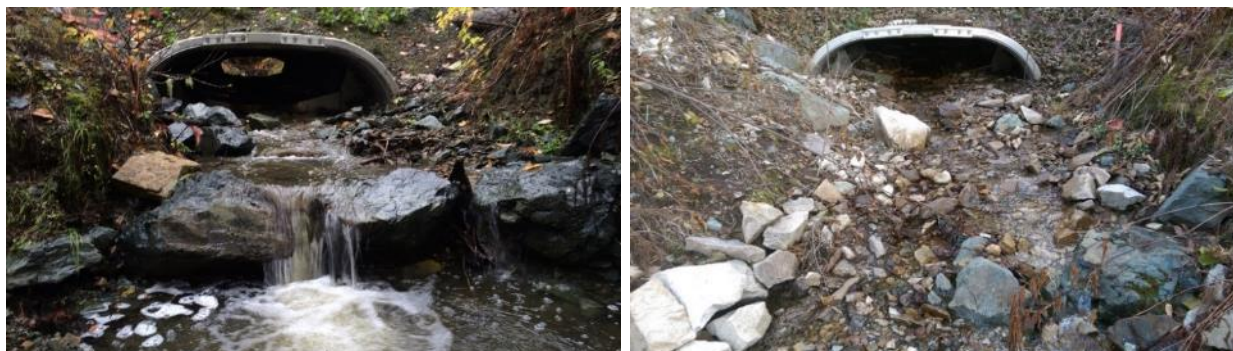
Monitoring revealed degradation of the downstream channel and minor modifications needed for the culvert to retain water. Additional funding was secured to address these issues.

Culvert outlet pre and post channel reconstruction in 2017.

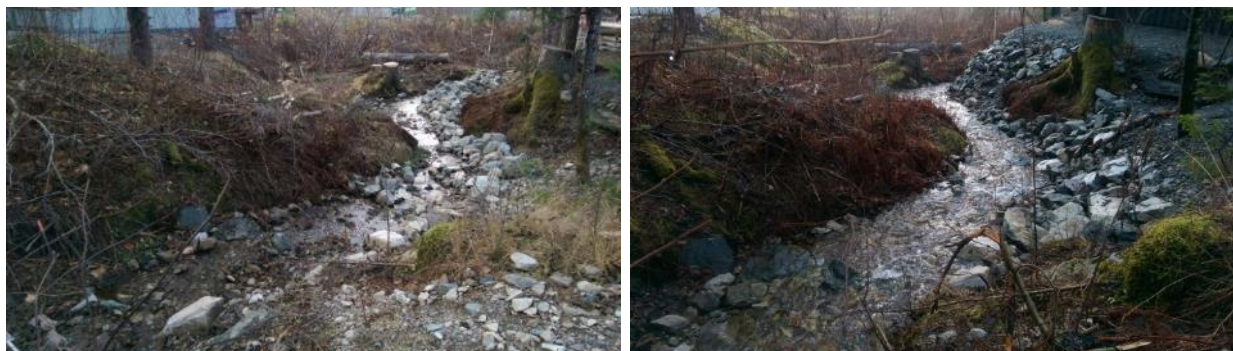
It was also noted during monitoring that an adjacent homeowner had placed riprap along the bank below the culvert. While this has been subsequently permitted, the riprap does encroach on the stream channel.

Outlet channel pre (left) and post (right) construction. Note the riprap added by homeowner.

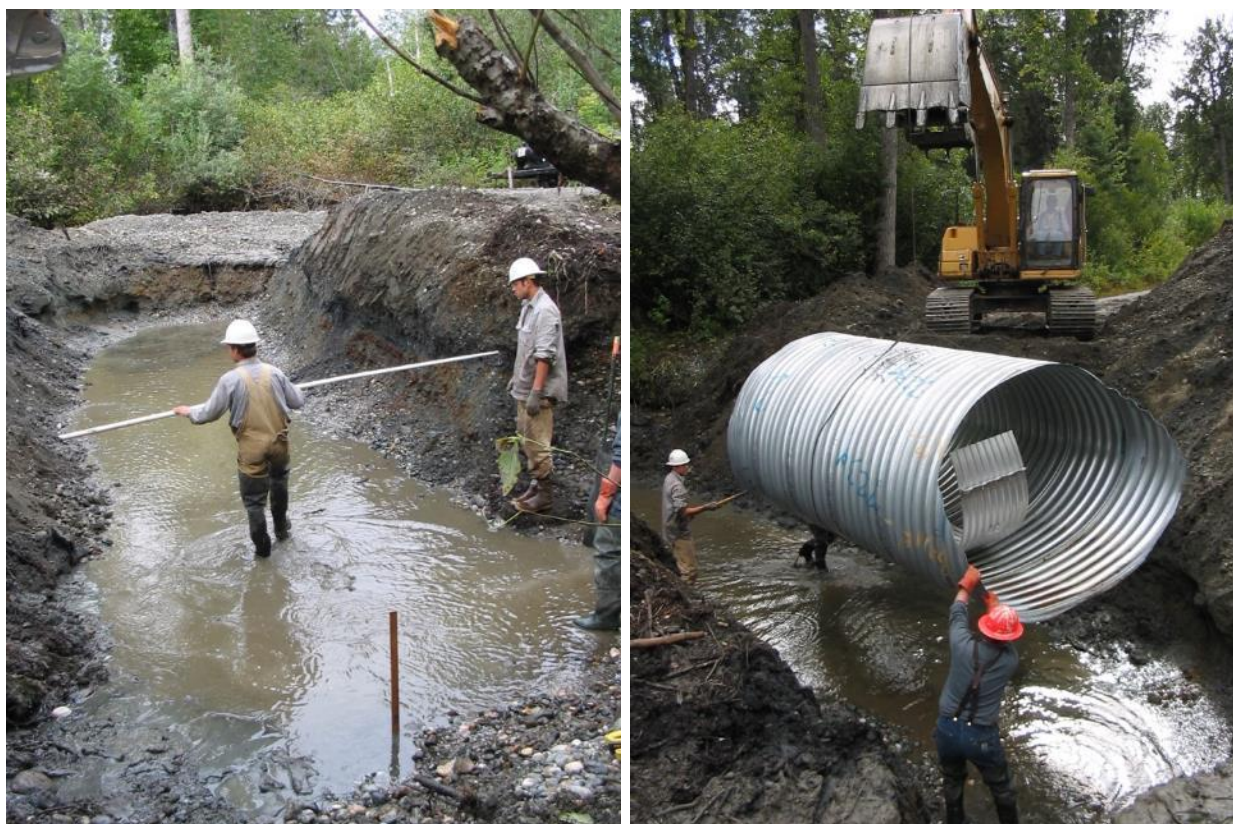
Culvert installation in 2004.

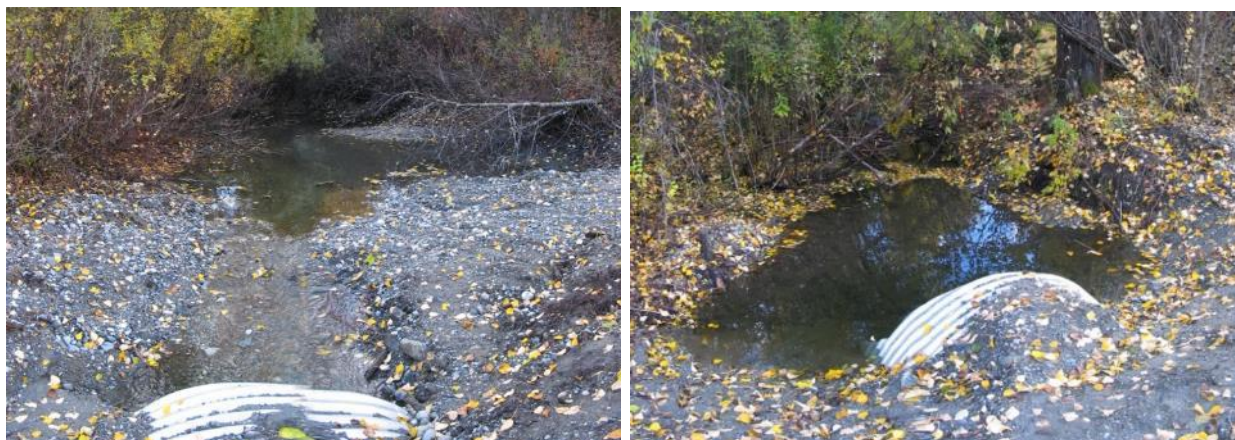
Culvert inlet (left) and outlet (right) approximately three weeks after installation in 2004.

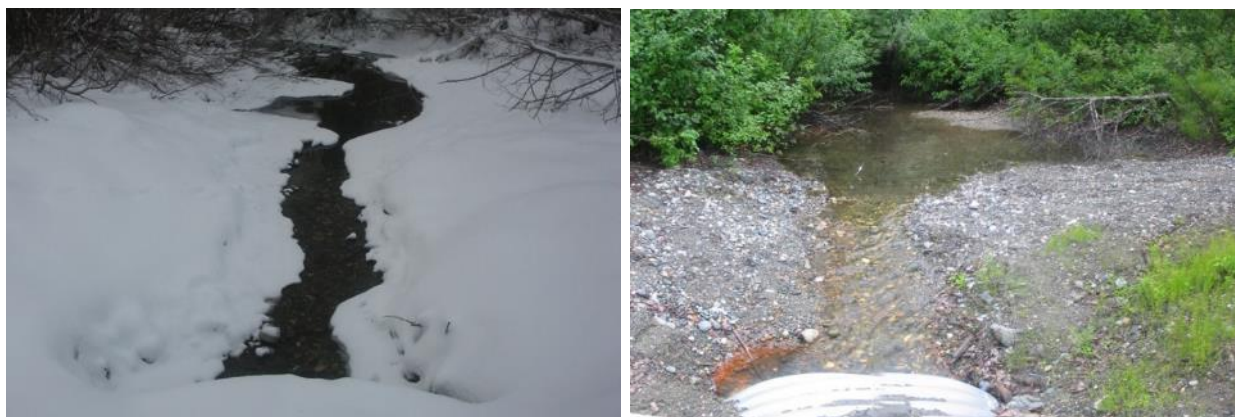
Culvert inlet in January 2005 (left) and June 2005 (right).

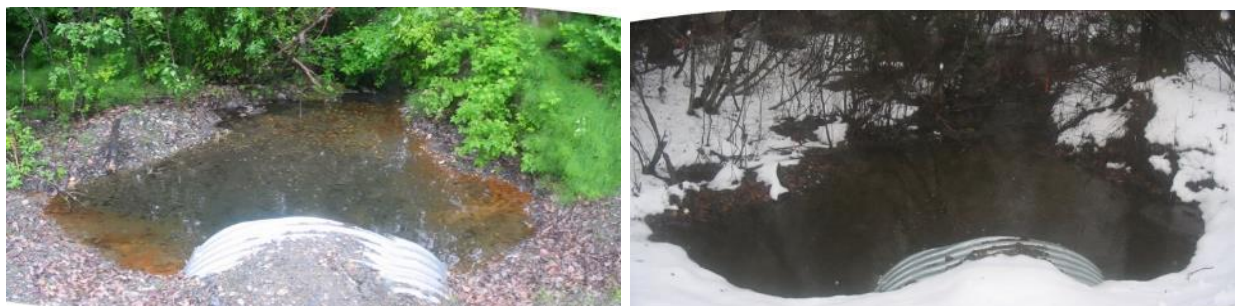
after the culvert was replaced. The culvert and fish passage appear stable after 15+ years.

Culvert outlet in June 2005 (left) and November 2005 (right).

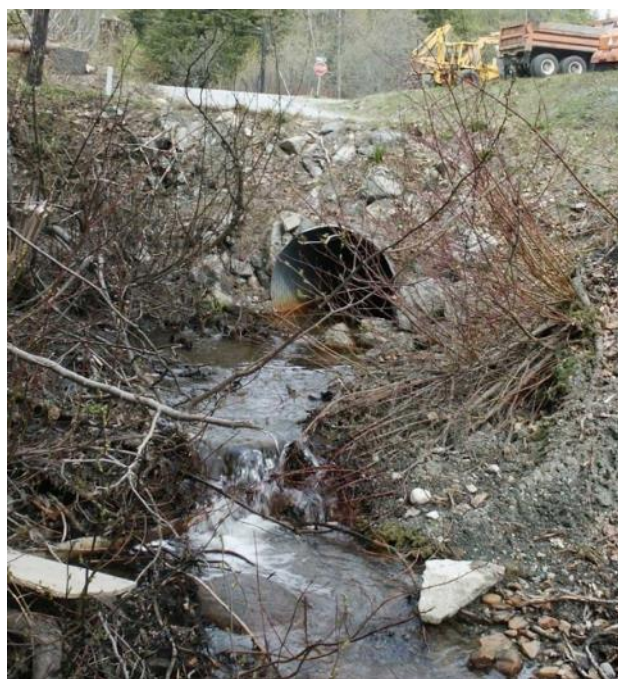
Culvert outlet pre replacement in 2008 (left). New culvert installation in 2008 (right).

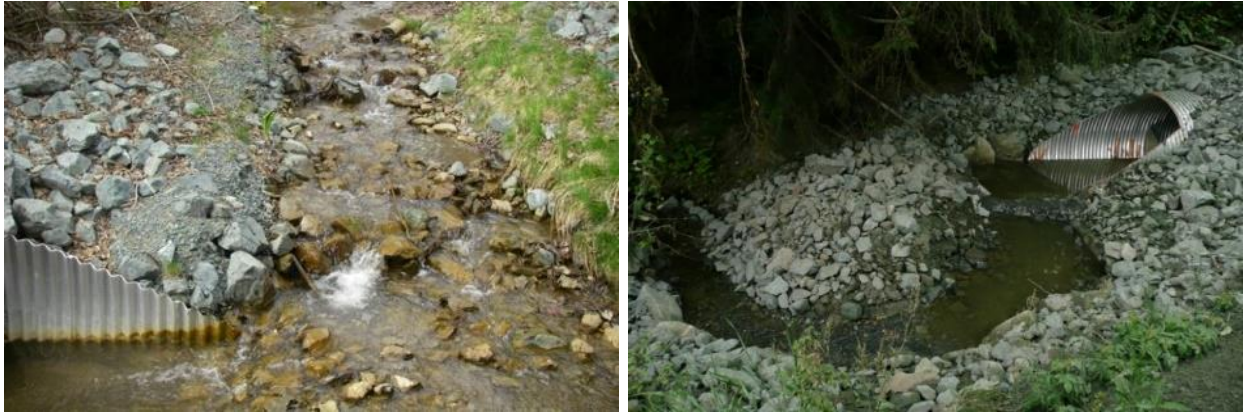
Culvert inlet (left) and outlet (right) shortly after installation in 2008.

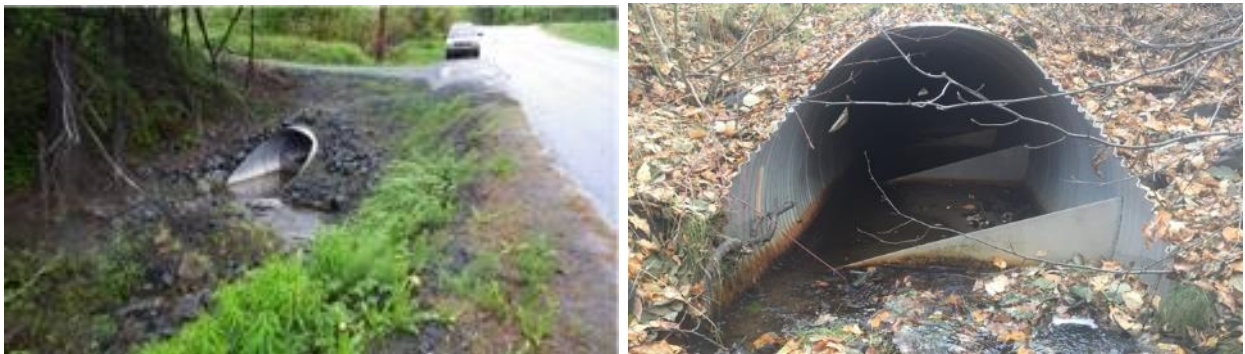
Culvert outlet in May 2012 (left). Inlet baffles in October 2020 (right).

- Continue to monitor how baffles hold sediment.

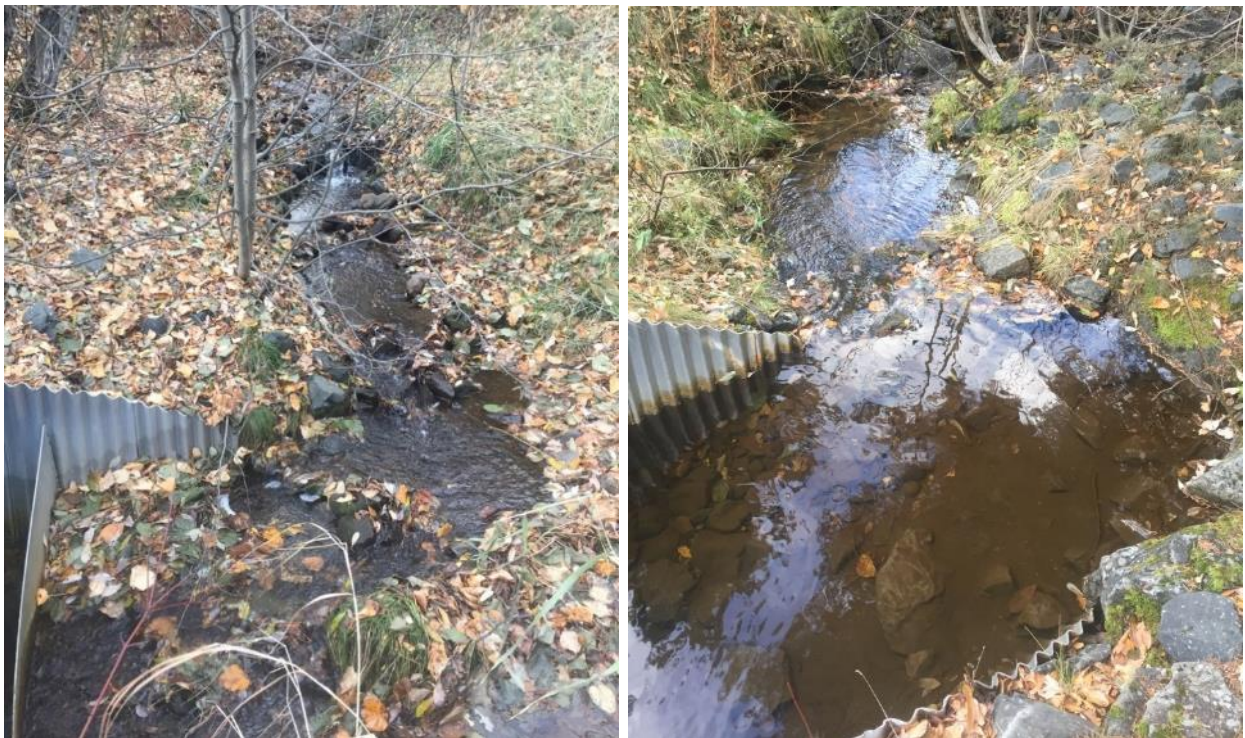
Culvert inlet (left) and outlet (right) in October 2020.

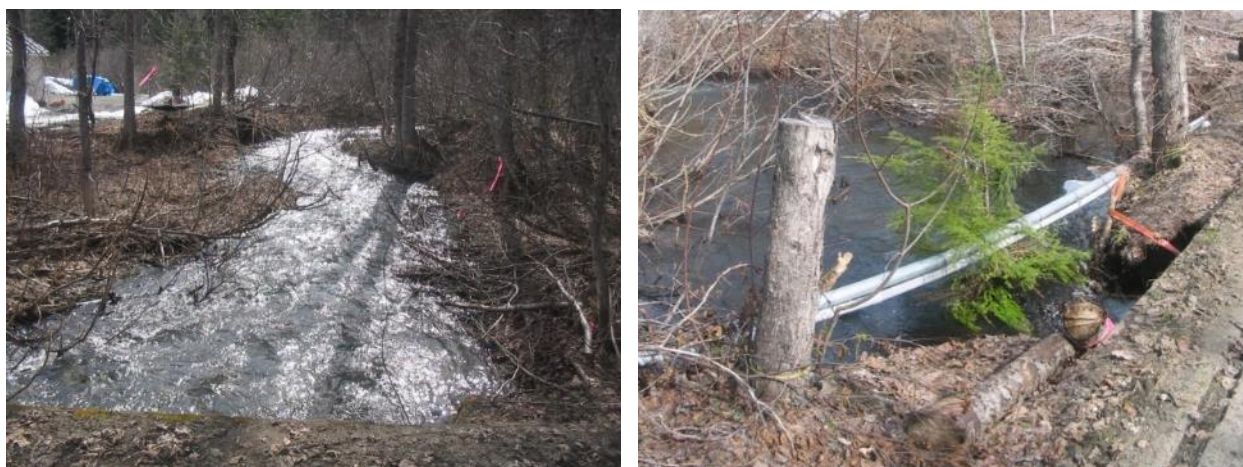
Studly culvert outlet (left) and inlet (right) channel prior to construction in April 2005.

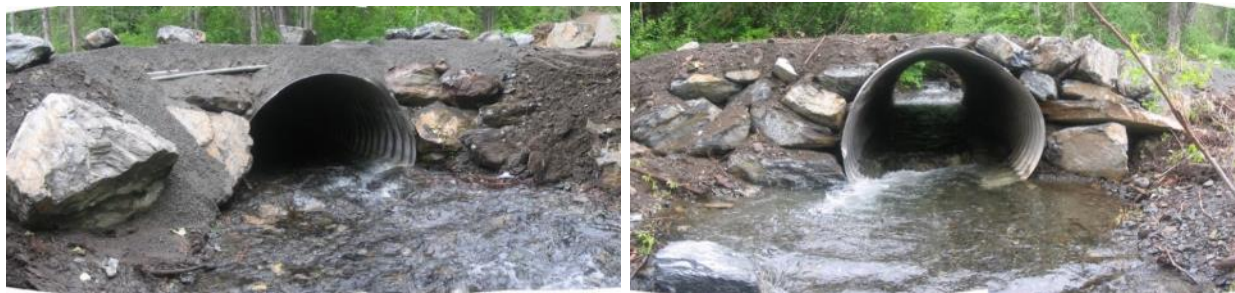
Culvert inlet (left) and outlet (right) with some bed material in June 2005.

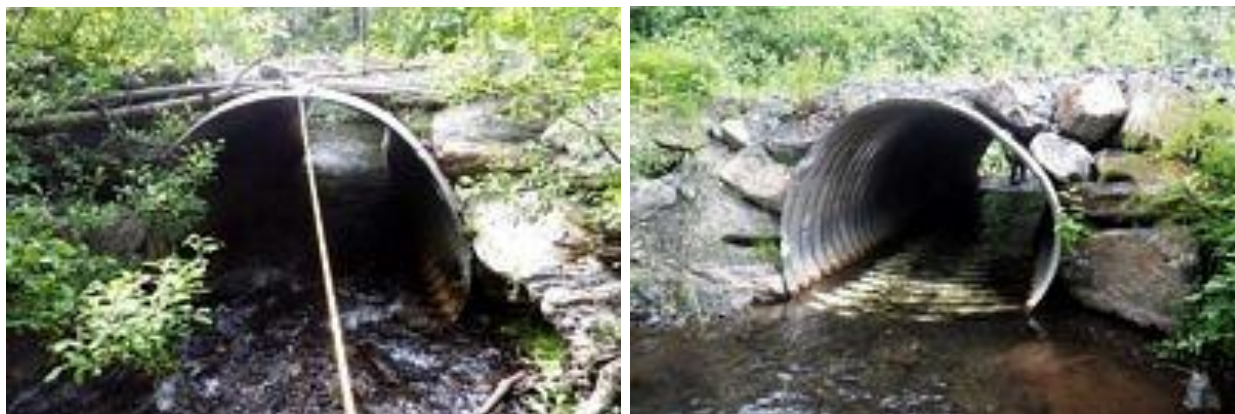
Culvert inlet (left) and outlet (right) in 2012.

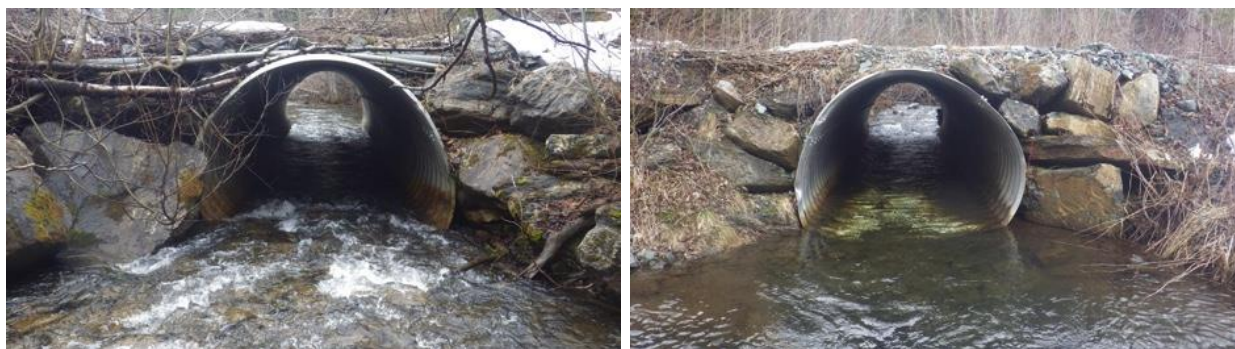
Culvert inlet (left) and outlet (right) in 2015.

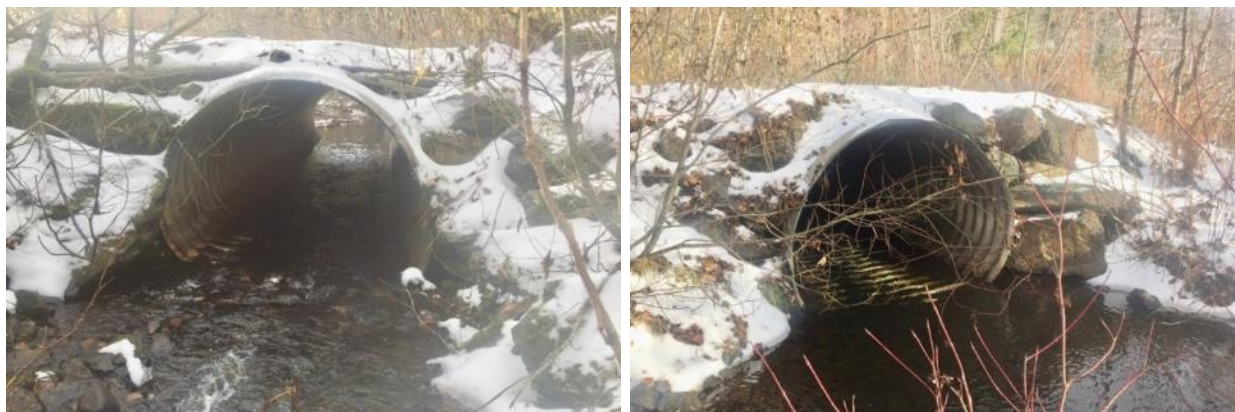
culvert. Currently the dam appears to be abandoned and failing. It appears water flows under and around the culvert as well as through it and the channel is significantly wider than the culvert.

**Project Significance:** This culvert is located on a private drive. Given its short length it can meet fish passage requirements if the invert was depressed 20% below the thalweg. A condition not met since shortly after installation. The upstream beaver dam has regulated flow to allow this culvert to hydraulically function with only one known failure.

Culvert inlet (left) and outlet (right) in October 2020.

- Continue to monitor the functioning of this culvert
- Plans to replace this culvert should be initiated.
- Downstream property owners should be alerted to the flood potential if the beaver dam should fail.
